**METRO NORTH  
ORAL HEARING**

**SD-2.6E Stage 2A Ground  
Movement Assessment Report  
RevA**

# **Mater Stop Existing Buildings and Structures Report**

## **Stage 2A: Ground Movement Assessment**

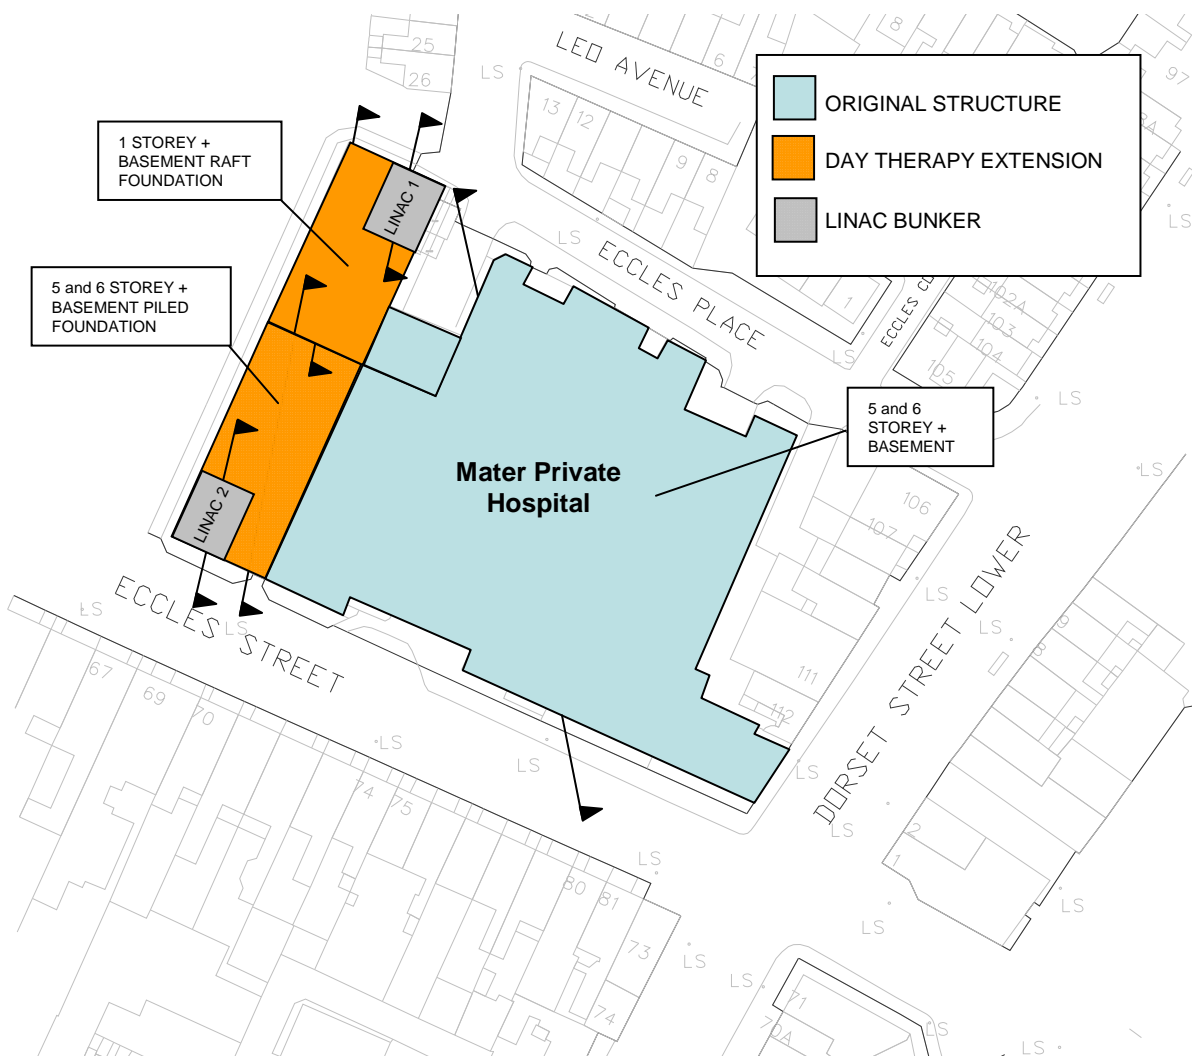
**Figure 7.1: Mater Private Hospital - Sections considered during potential damage assessment**

For assessment purposes 5 specific sections of the hospital building have been considered, Figure 7.1, refers.

The BREXIS analysis indicates *negligible* damage is expected to this part of the hospital, with a maximum settlement of 13mm anticipated adjacent to Eccles Place.

The 1 storey portion of the Day Therapy extension is an approximate rectangle of 17m by 21m, with a basement. This portion of the building is considered to rest upon a raft foundation with a depth of approximately 3.1 mbgl existing ground level. The BREXIS analysis indicates negligible damage is expected to this part of the hospital, with a maximum settlement of 23mm anticipated adjacent to the proposed Mater Stop Station box.

The 5 storey portion of the Day Therapy extension is approximately rectangular in shape, 17m by 37m, with a basement. This portion of the building is considered to be founded upon piled foundations, a uniform pile toe depth of 10mbgl with the pile cap at 3.1mbgl has been assumed. BREXIS analysis indicates negligible damage is expected to this part of the hospital, with a maximum settlement of 6mm anticipated at pile toe level.

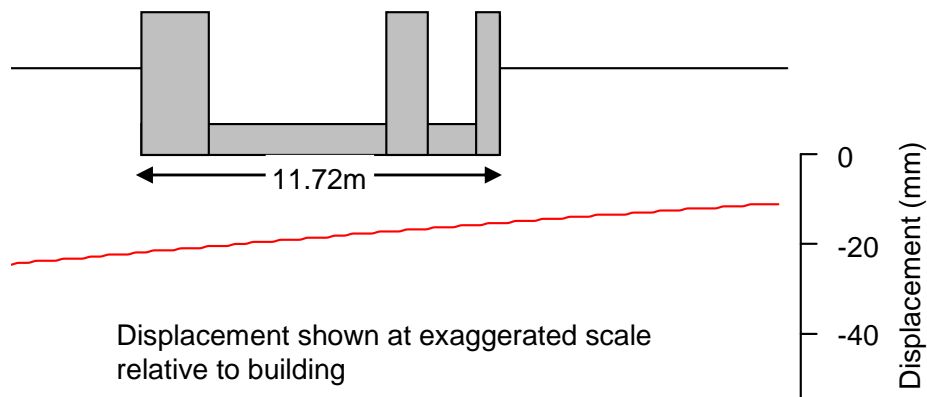
**Figure 7.2: Foundation Settlement Level Across LIN-AC 1, north to south**

The LIN-AC bunkers house movement sensitive LinAcc equipment. Each bunker has approximate rectangular dimensions of 12m by 10m and is formed with very thick discrete reinforced concrete walls and roof slab with a thin ground bearing, independent floor slab. Anticipated Settlement across LIN-AC 1, as shown in Figure 7.2, is 22mm below the northern reinforced concrete wall reducing to 15mm below the southernmost reinforced wall. For LIN-AC 2mm of settlement is anticipated below the northern reinforced concrete wall and 1mm below the southern reinforced concrete wall. BREXIS analysis indicates negligible damage to the structure of both bunkers is expected. However, a full assessment of the affect of the anticipated ground movement on the sensitive LinAcc equipment will need to be undertaken. An assessment will also need to be undertaken of the likely effects of differential movement between elements of the building supported by different foundation systems.

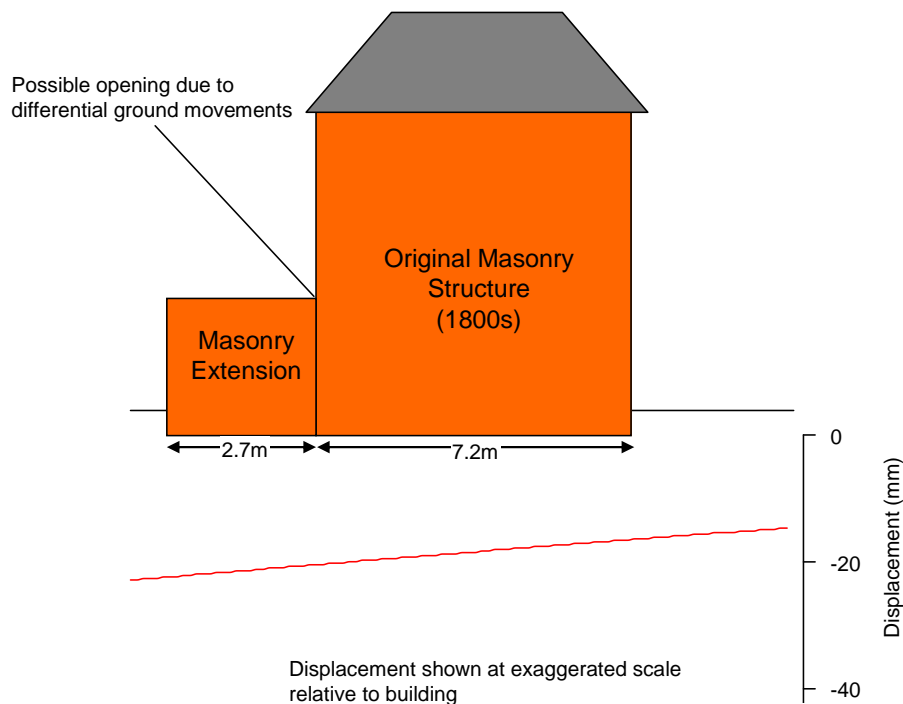
**Figure 7.3: Foundation Level Settlement across typical Leo Street Property**

The maximum anticipated tensile strains for the Leo Street properties Nos. 3 -21 suggest that only *negligible* damage due ground movements associated with the proposed Mater Stop Box excavation will occur, see Table 6.2. However, a typical Leo Street property consists of both the original two storey 1800s masonry structure and a more recent extension at the rear of the property. The interface between the original structure and the extension could be susceptible to some cracking and 'opening up' as the buildings are in essence two abutting masonry structures that will respond separately to excavation induced ground movement. Figure 7.3 presents the anticipate foundation level settlement across a typical cross-section of one of the Leo Street properties however the amount of movement is likely to depend on individual extension construction.

Nos. 1-2 and Nos. 22-24 Leo Street are situated with the direct vicinity of closed corners of the proposed Mater Stop Excavation. Within the vicinity of the closed corners there will be a superposition of ground movements from the adjoining walls of the excavation. It is acknowledged that modelling limitations of the closed corner movements within GRP mean that this superposition is not considered; consequently no BREXIS assessment for these 4 properties has been presented. It is expected that this will be *very slight to slight* and may require further assessment.

Under the circumstances described above it is unlikely that localised damage will exceed the *slight to moderate* threshold for the Leo Street properties. However it is recommended that the potential damage to Leo Street properties is reviewed at Stage 2B assessment once the nature of the building foundations is ascertained and the nature of any existing building damage is clarified. It is recommended that 2 & 21 Leo Street also undergo a full Building Characterisation Survey (as detailed in Appendix C) to review the nature and extent of the existing building damage.
