**METRO NORTH
ORAL HEARING**

Assessment of Magnetic Field Strengths at St. James
and Comparison with Rotunda
March 2009

**MEASUREMENT OF MAGNETIC FIELD STRENGTHS FROM LUAS AT ST
JAMES'S HOSPITAL AND COMPARISON WITH ROTUNDA DATA**

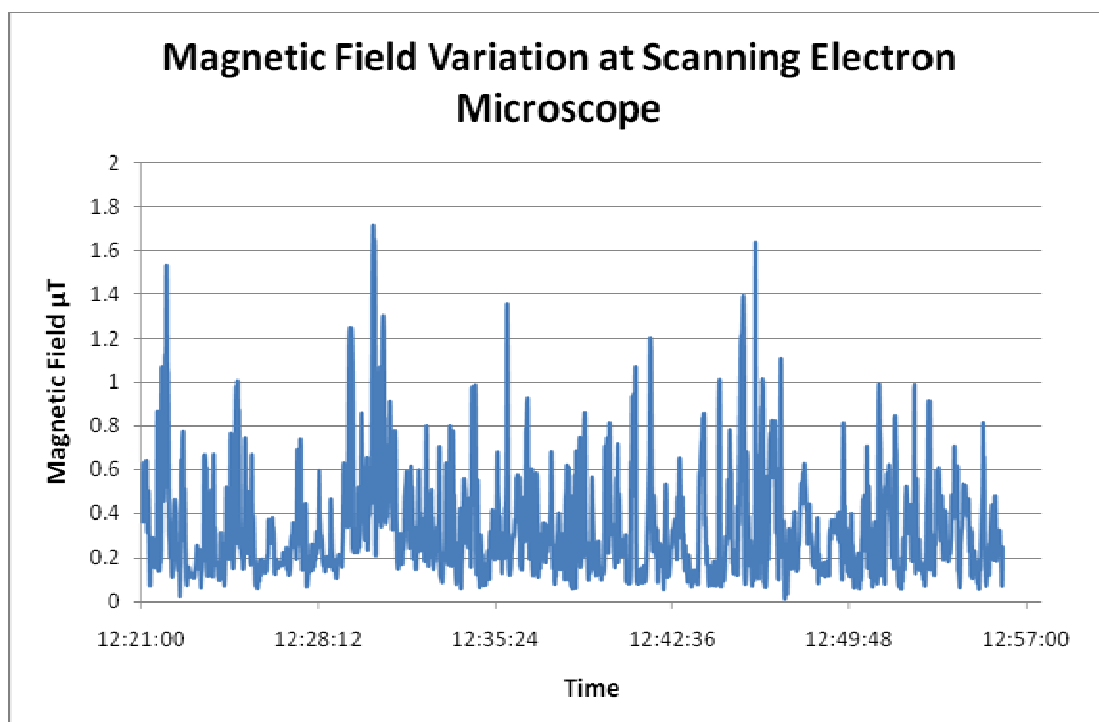
Figure 1 shows the results taken over a 40 minute period. During the measurement period eight trains passed. The survey was conducted on March 13th 2009.

Figure 1: Magnetic Field Measurements

It was found that the magnetic field attained levels up to 1.7 μ T.

As such, it can be seen that the electron microscope was not experiencing interference from magnetic field levels equal to and greater than those predicted at the Rotunda Hospital.

Measurements at a similar electron microscope located at St James's Hospital laboratory beside the Luas Red line showed that magnetic fields attained levels of up to 1.7 μT .

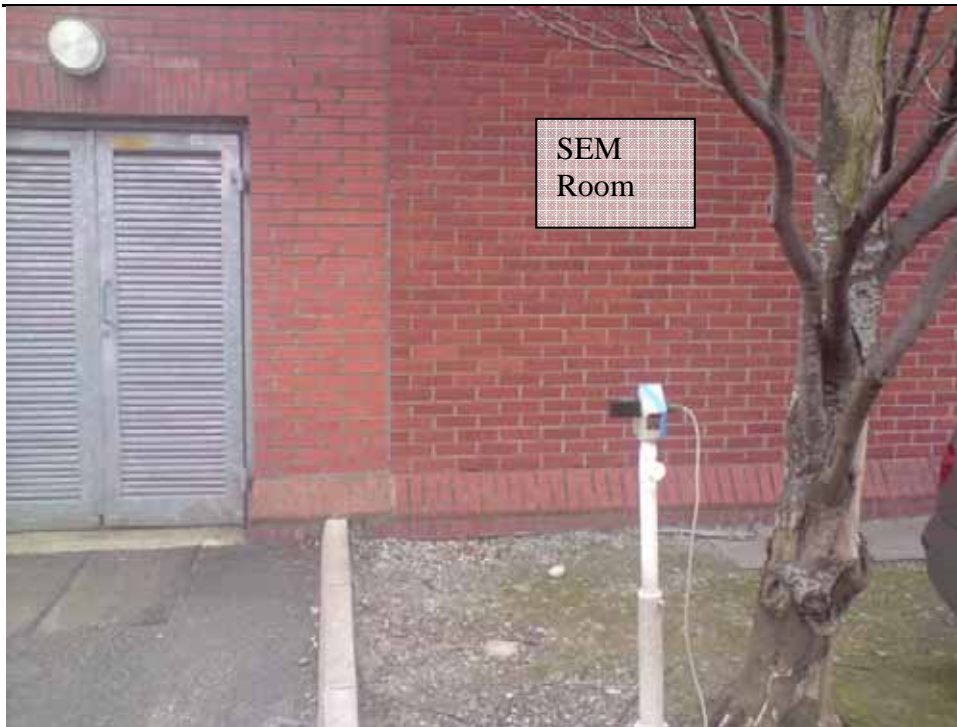
Photograph 1: Outside electron microscope Room

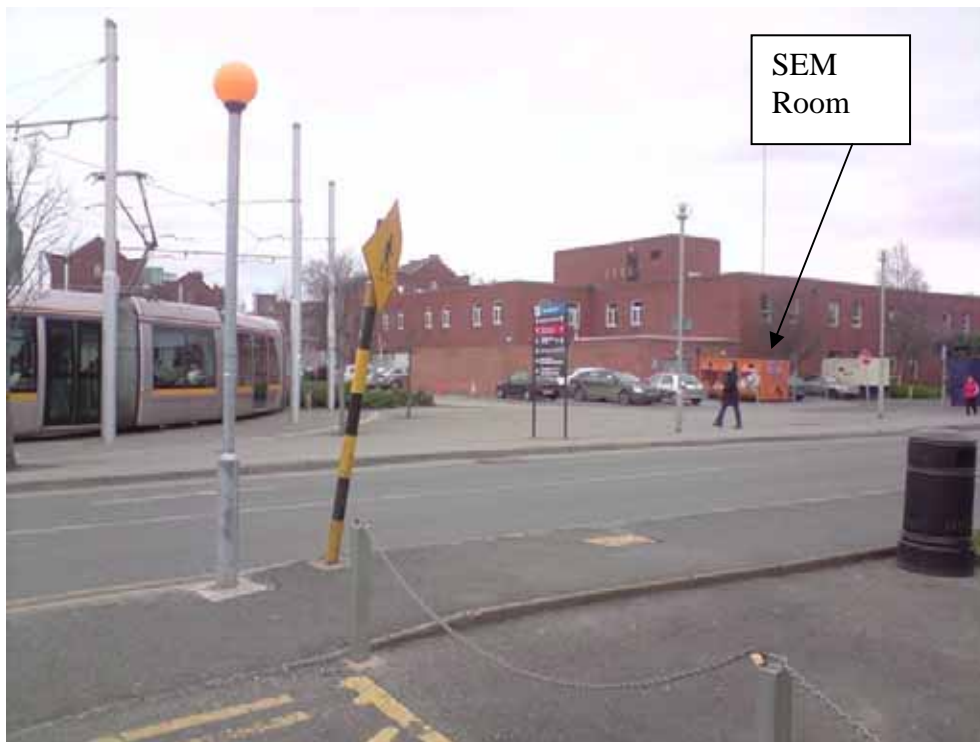
Photograph 2: Relationship between Luas and Electron Microscope Room

A similar electron microscope has been in use at the St James's Hospital laboratory for several years. Whilst the electron microscope was from a different manufacturer the unit was similar in terms of age and technology. This electron microscope was located 35m linear distance from the Luas Red line. As such, this provided a suitable reference site to determine if interference would be expected.
