# Dublin Metro North

## Baseline Vibration Monitoring Report

November 2008

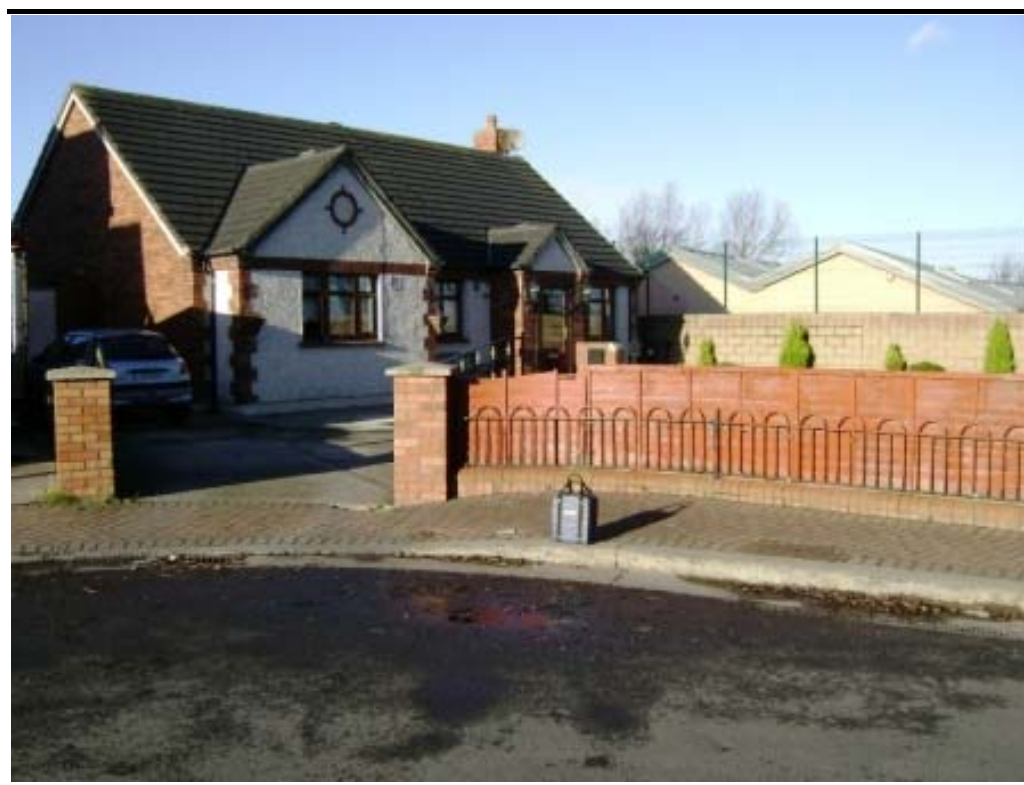
Figure A1.1 *Seatown Walk, Swords*

Most residential receptors along the proposed Metro North alignment are affected by road traffic vibration, but at a low level which is unlikely to be above the DIN 4150-2 guideline levels. However, at Seatown Walk in Swords and at Griffiths Avenue vibration was in excess of DIN 4150-2 guidelines, although subjectively the levels were low.

10/1/08	18:00	7:15	34	As above	Equipment Failure: Not Recorded		Luas (near track) 0:15 - 0:25 Luas (far track) 0:59 - 1:15 Luas (near track) 6:15 - 6:40 Luas (far track) 6:56 - 7:15
10/1/08	23:05	5	35	On kerb adjacent with No. 20 and level with the front of the school, Seatown Walk, Swords	0.16 0.11 0.15  KB <sub>FTr</sub> =0.11	Au=0.15/0.1   Ar =0.07/0.05	No discernable vibration No local traffic passing 1 x car passing @ 4:45
10/1/08	23:15	5	36	Speed bump / table	0.12 0.10 0.08	0.15/0.1	Complies with standard assuming that speed bumps generate vibration during the day and infrequently at night.
