BASELINE DUST DEPOSITION SURVEY REPORT

Railway Procurement Agency
Parkgate Business Centre
Parkgate Street
Dublin 8

Report Ref. 16124
17th February 2010

This report presents the results of a dust deposition survey which was carried out at 48 sampling locations (D-1 to D-48) along the proposed Metro North alignment. Dust deposition rates have been measured over a four month period from 18th August – 16th December 2009.

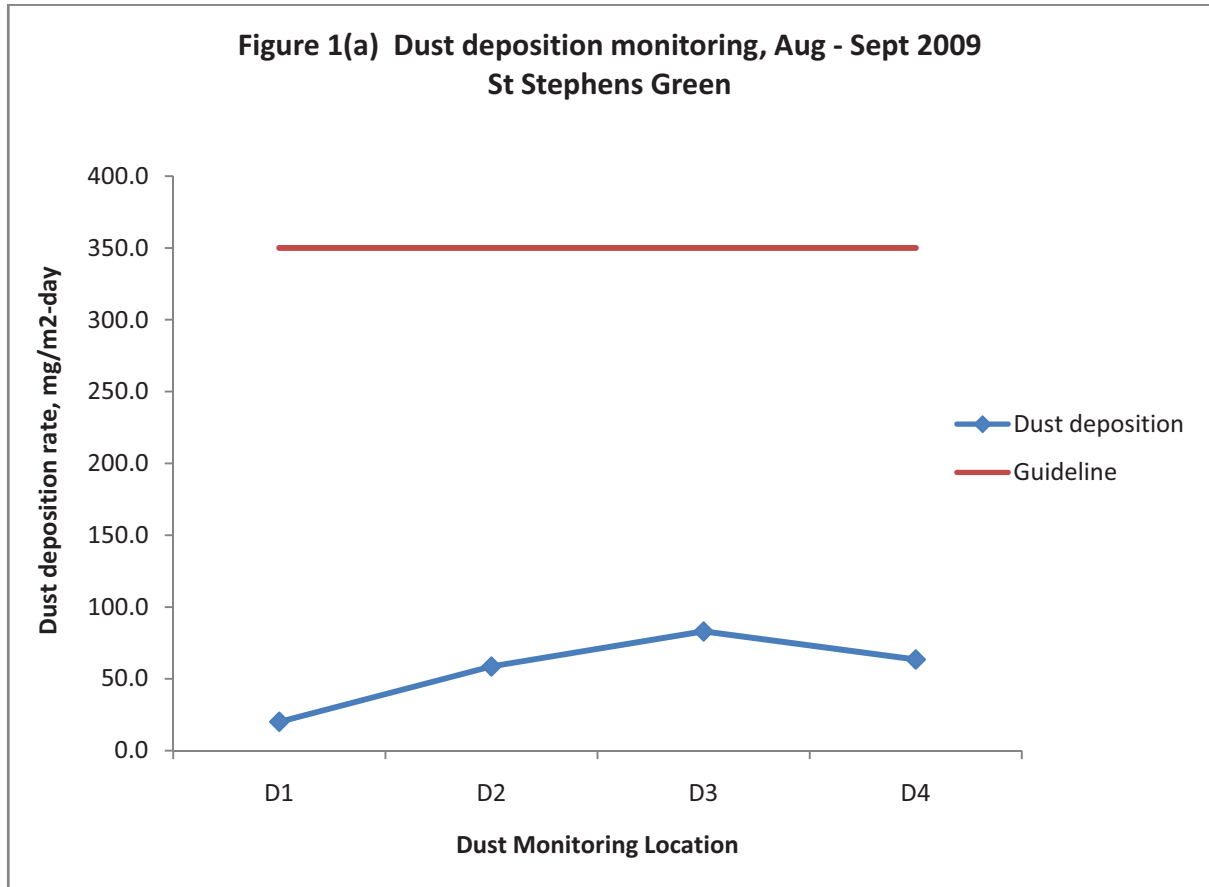
Graphs 1(a) to 1(i) provide details of the dust deposition levels at all locations (on a monthly basis) during Interval #1

- Interval #1 : Tables 2a and 2b and Figures 1(a) to 1(i)
- Interval #2 : Tables 2a and 2b and Figures 2(a) to 2(i)
- Interval #3 : Tables 2a and 2b and Figures 3(a) to 3(i)
- Interval #4 : Tables 2a and 2b and Figures 4(a) to 4(i)

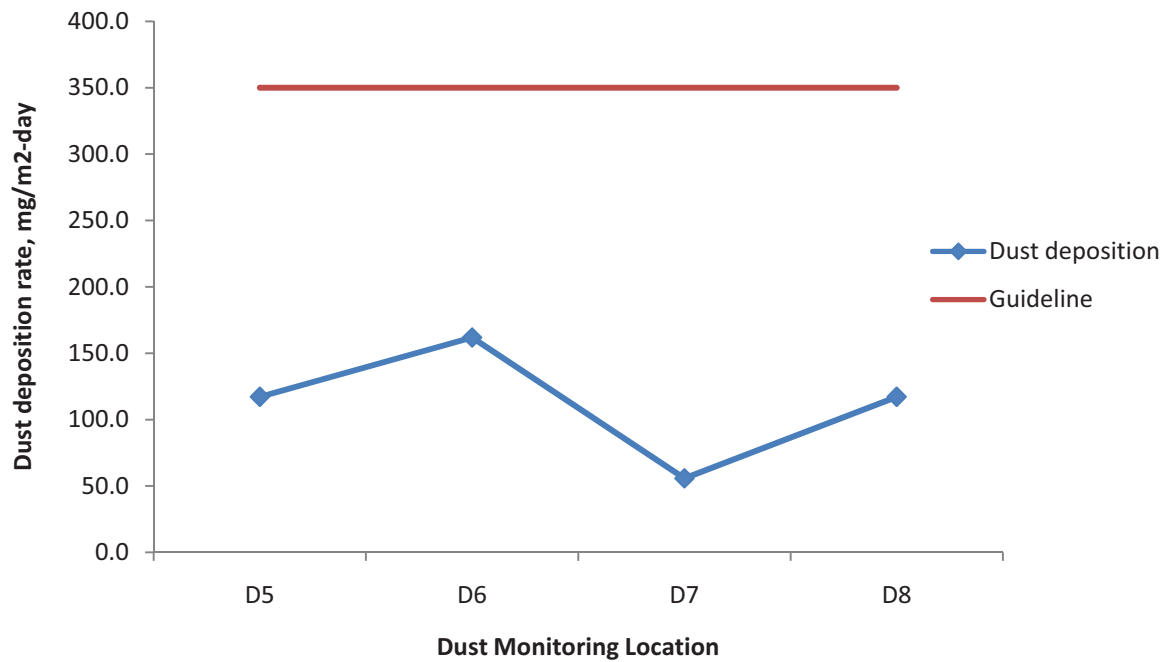
**Figure 1(b) Dust deposition monitoring, Aug - Sept 2009
Parnell Square**

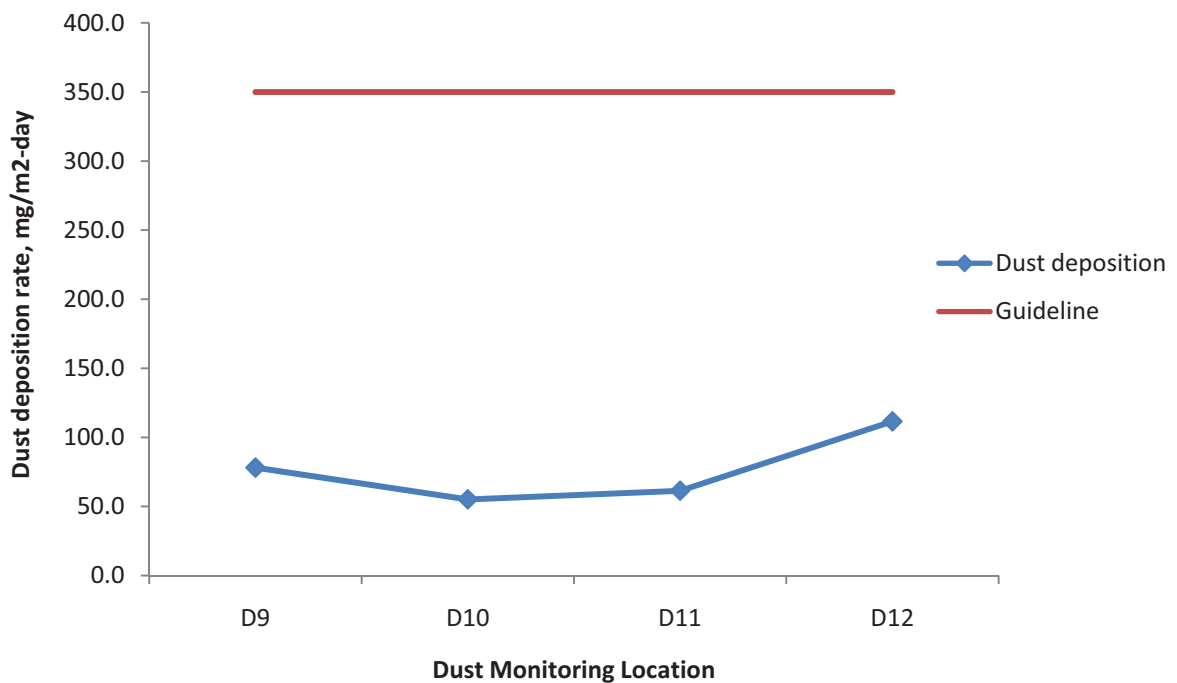
**Figure 1(c) Dust deposition monitoring, Aug - Sept 2009
Mater Hospital**

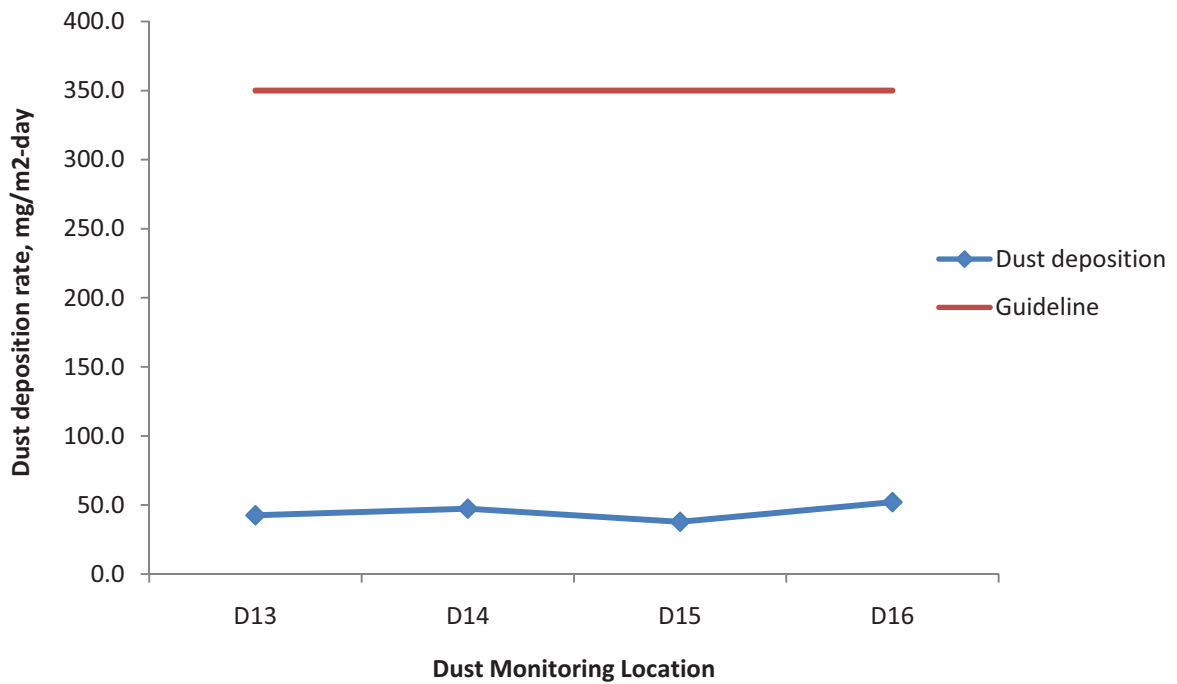
**Figure 1(d) Dust deposition monitoring, Aug - Sept 2009
Home Farm Road Drumcondra**

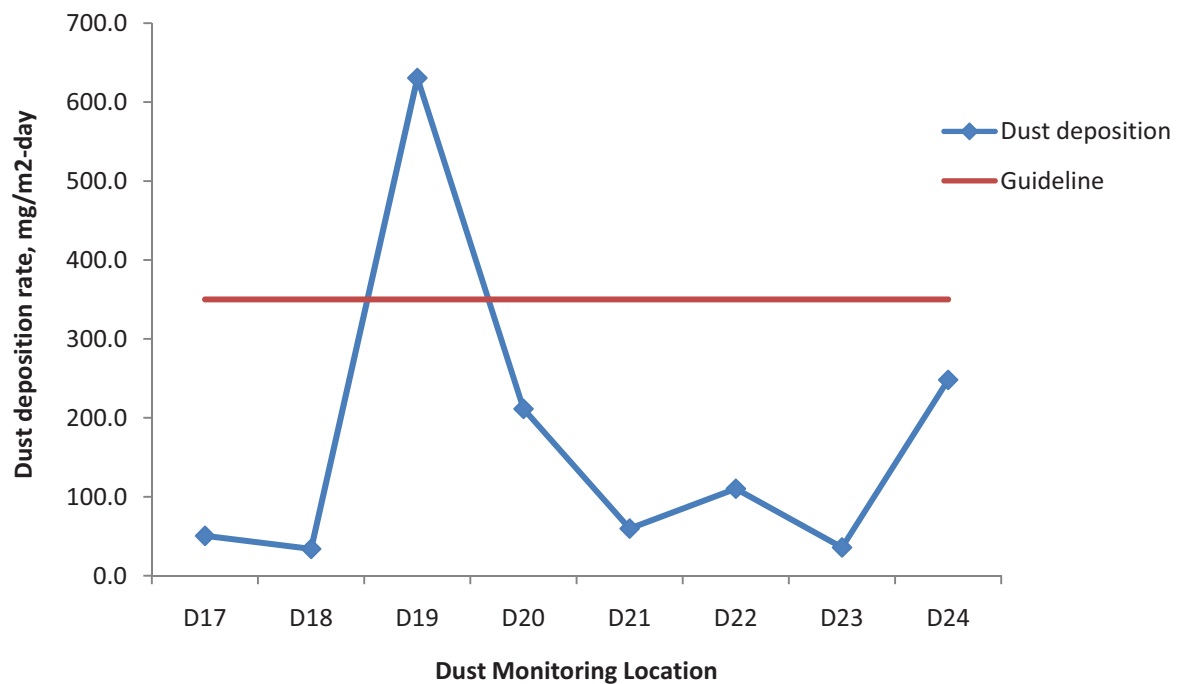
**Figure 1(e) Dust deposition monitoring, Aug - Sept 2009
Albert College Park**

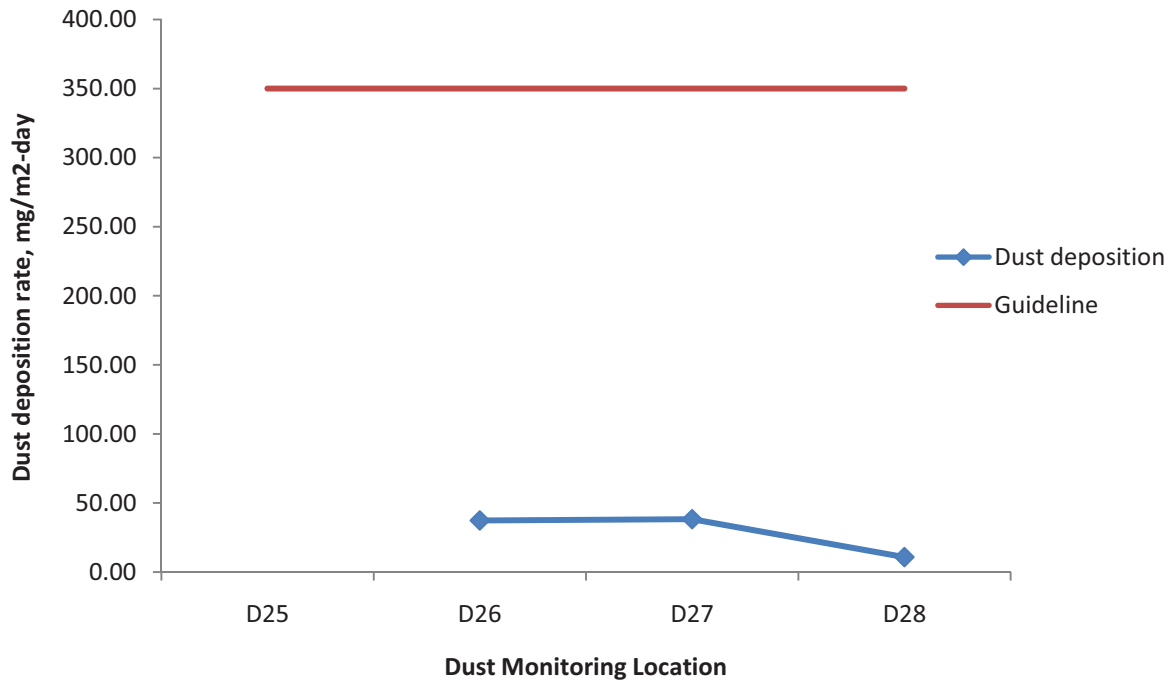
**Figure 1(f) Dust deposition monitoring, Aug - Sept 2009
Albert College Estate**

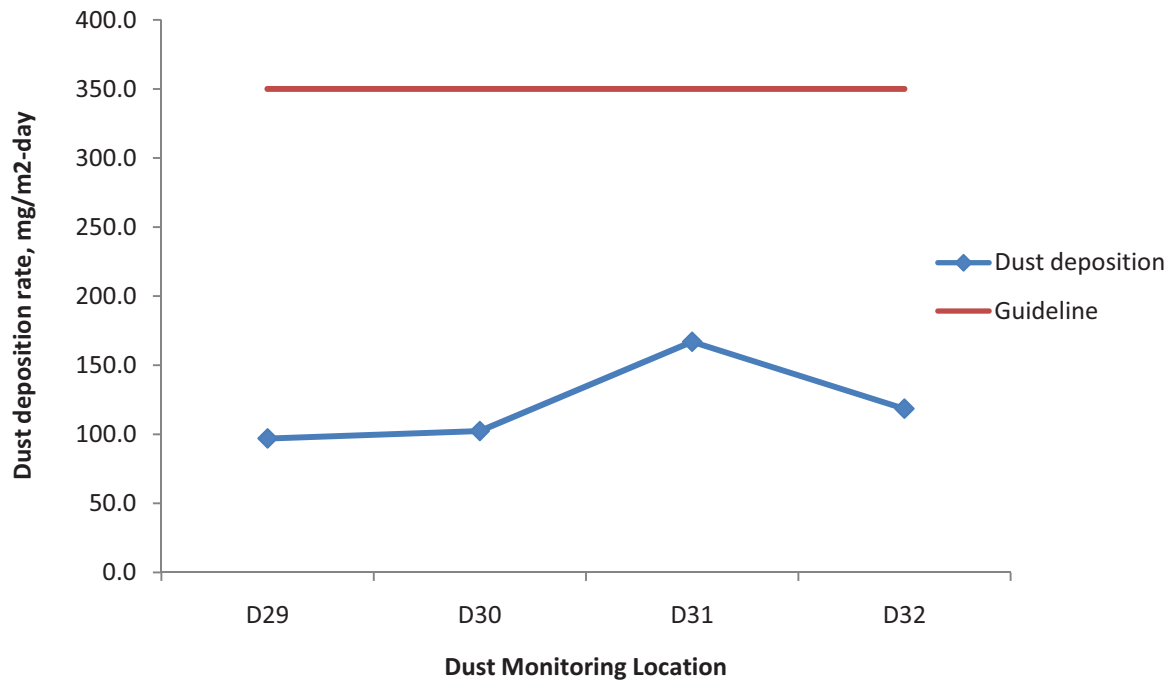
**Figure 1(g) Dust deposition monitoring, Aug - Sept 2009
Swords Pavilion**

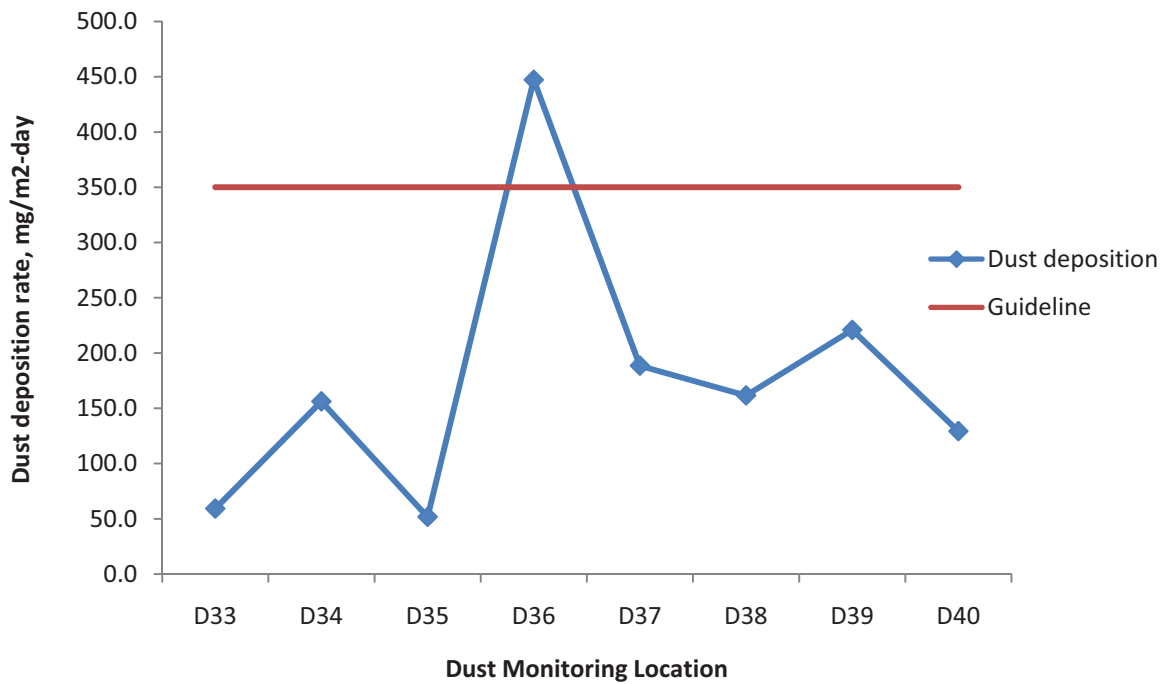
**Figure 1(h) Dust deposition monitoring, Aug - Sept 2009
Seatown Road Roundabout**

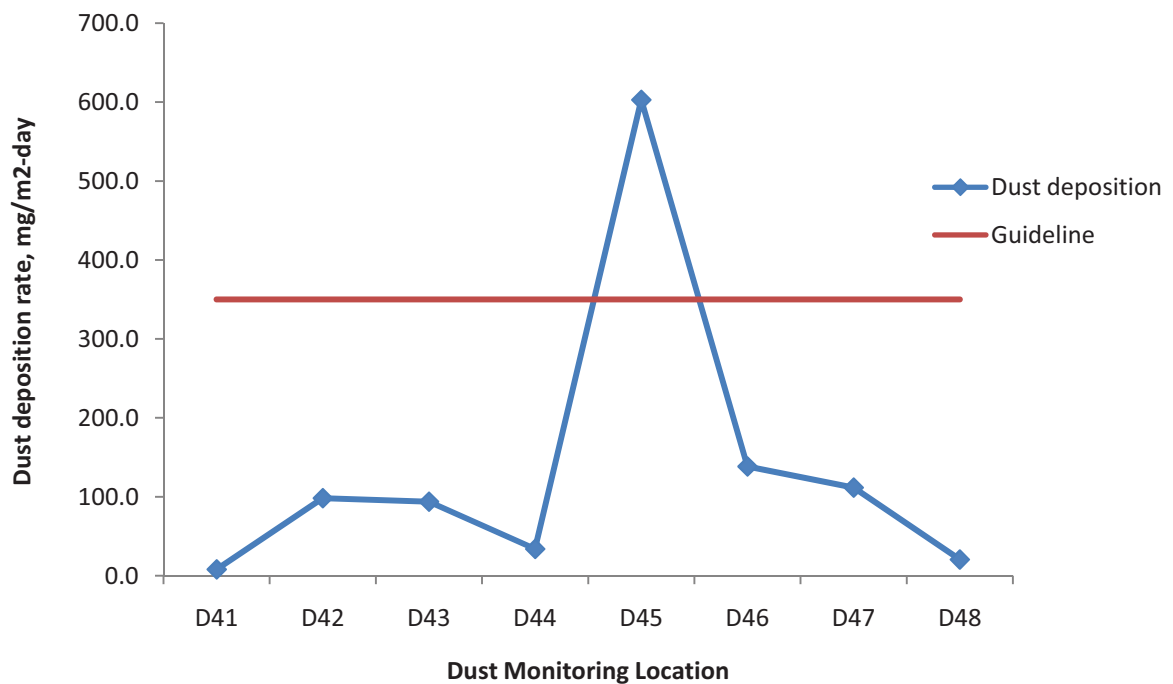
**Figure 1(i) Dust deposition monitoring, Aug - Sept 2009
Belinstown**

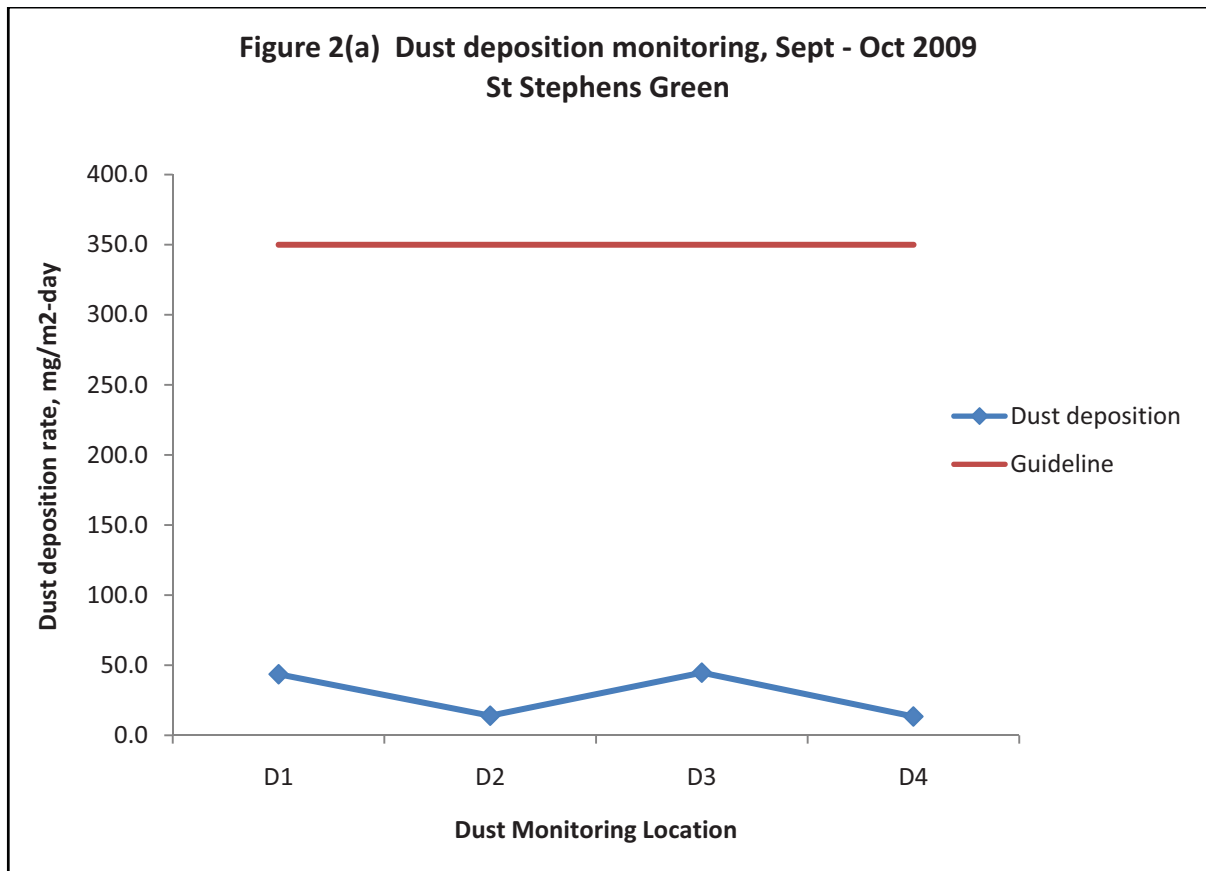
Graphs 2(a) to 2(i) provide details of the dust deposition levels at all locations (on a monthly basis) during Interval #2

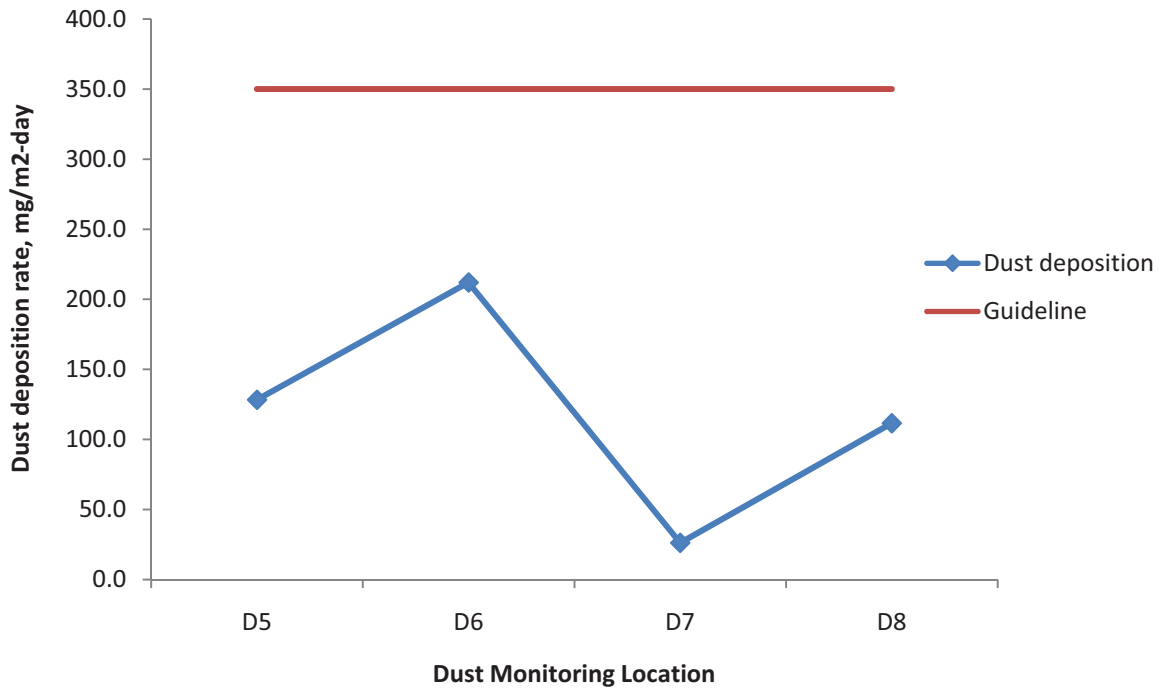
**Figure 2(b) Dust deposition monitoring, Sept - Oct 2009
Parnell Square**

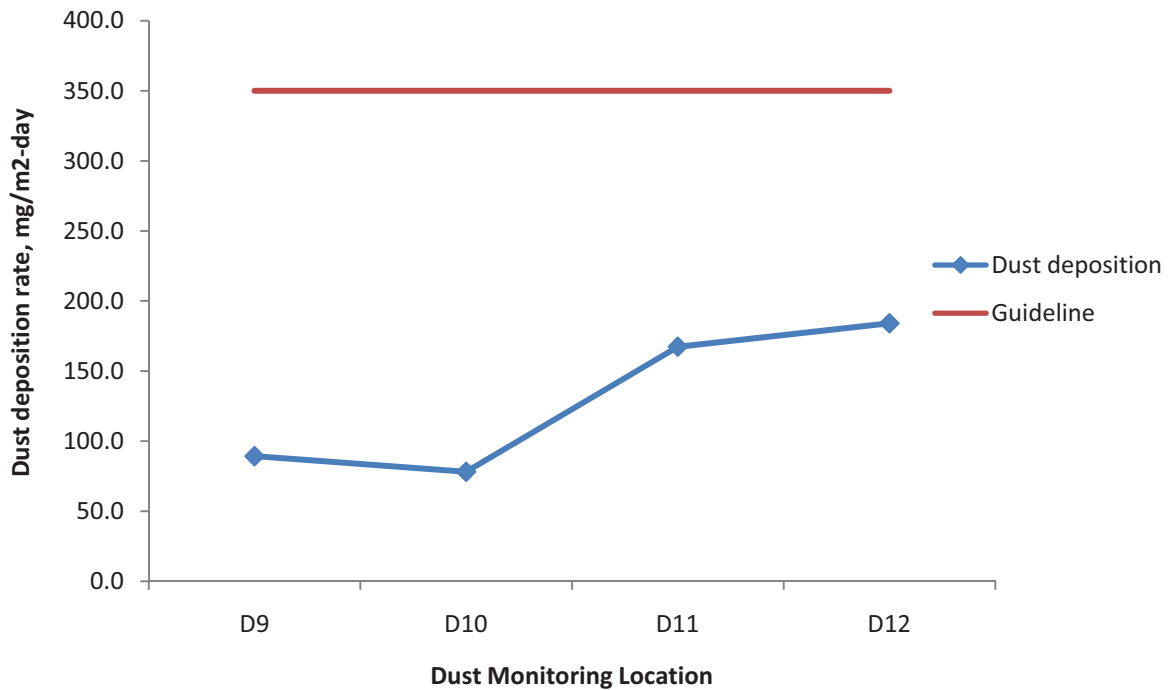
**Figure 2(c) Dust deposition monitoring, Sept - Oct 2009
Mater Hospital**

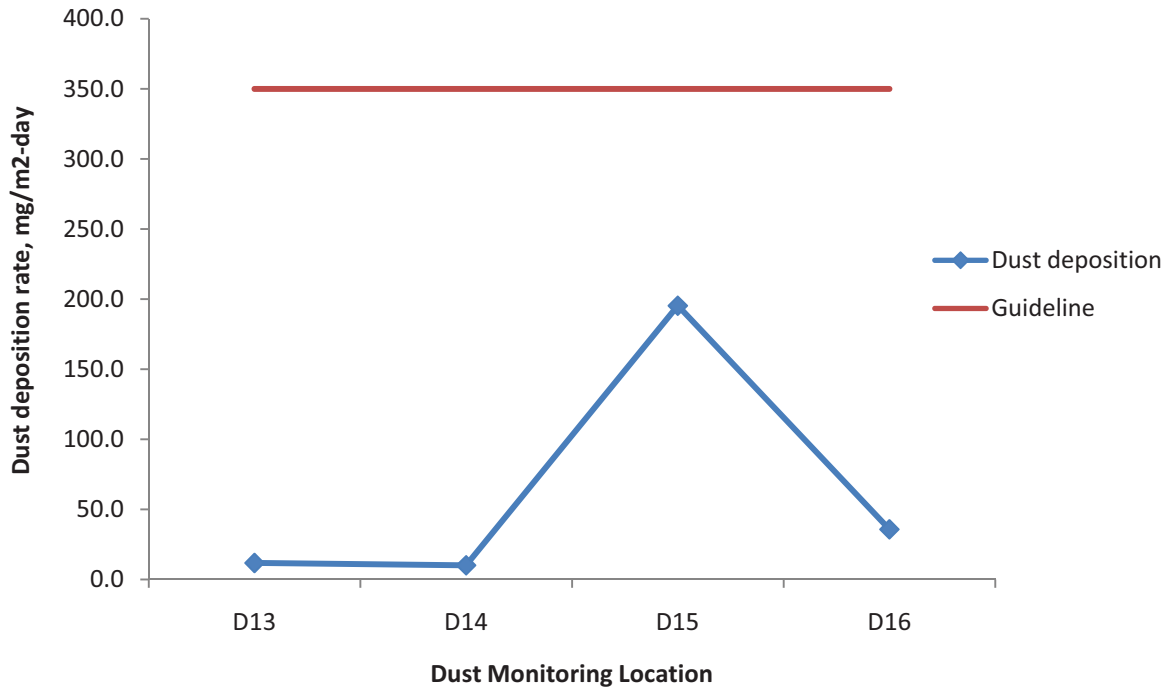
**Figure 2(d) Dust deposition monitoring, Sept - Oct 2009
Home Farm Road Drumcondra**

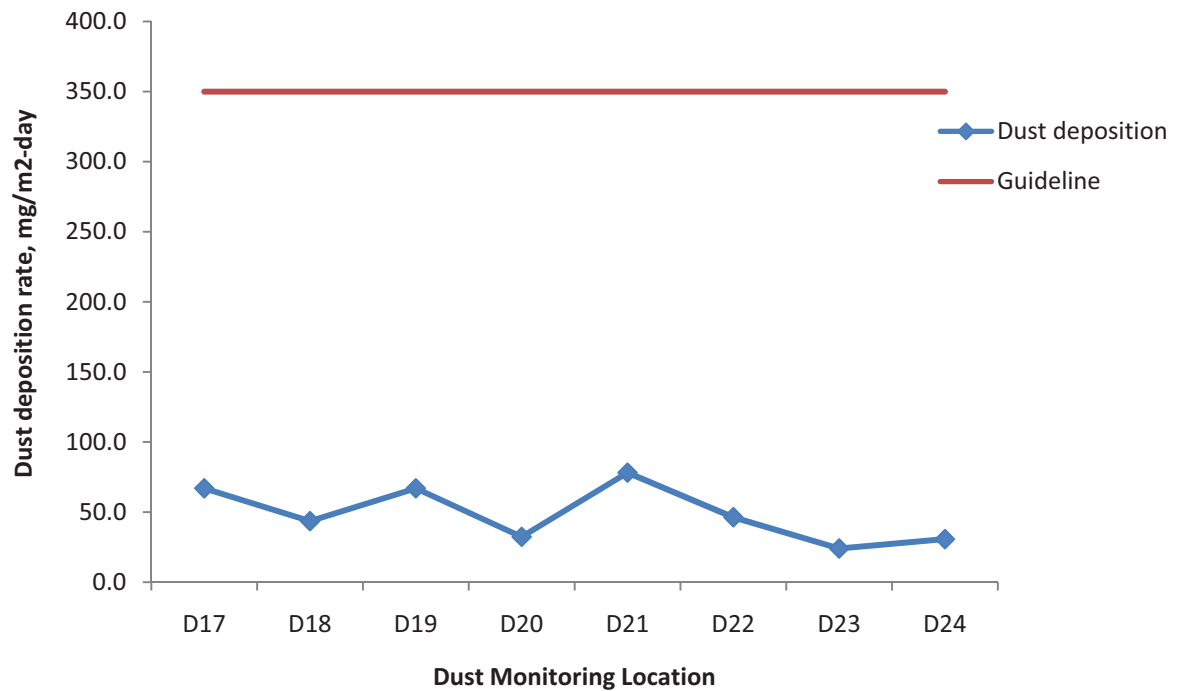
**Figure 2(e) Dust deposition monitoring, Sept - Oct 2009
Albert College Park**

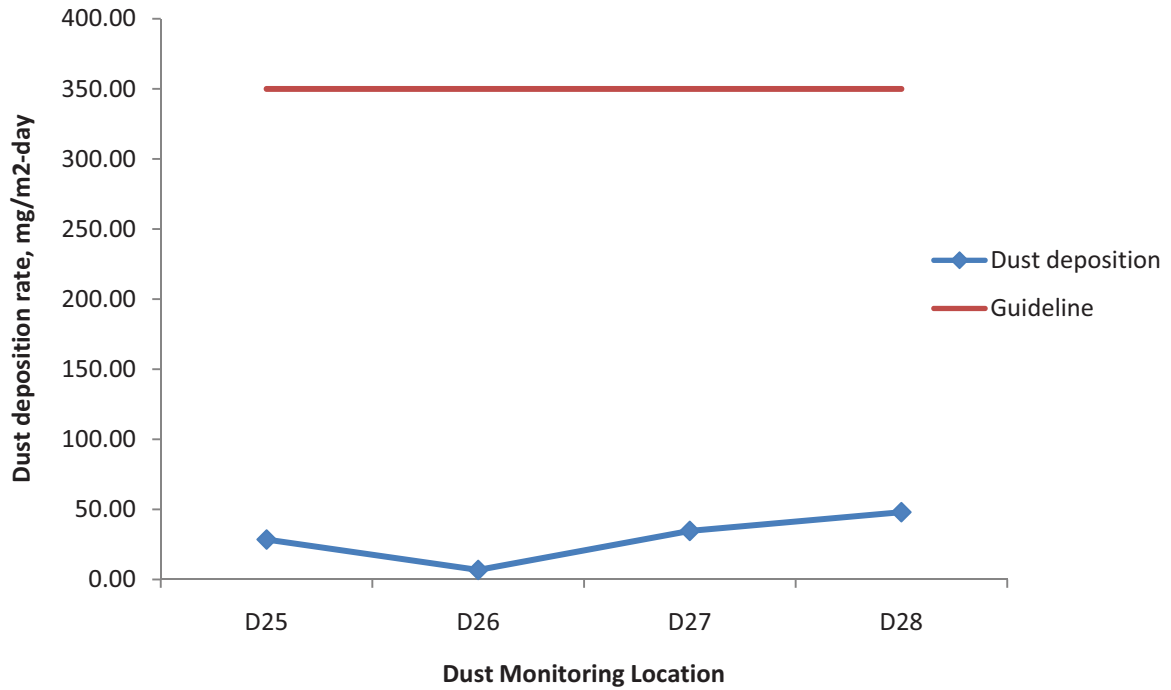
**Figure 2(f) Dust deposition monitoring, Sept - Oct 2009
Albert College Estate**

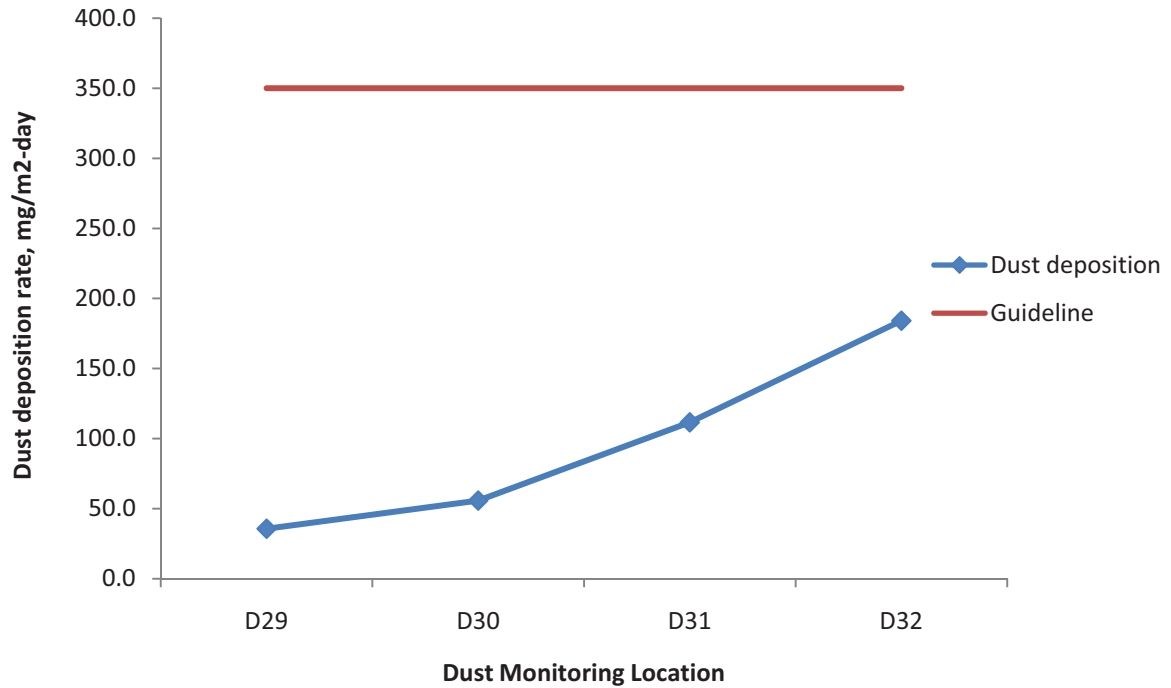
**Figure 2(g) Dust deposition monitoring, Sept - Oct 2009
Swords Pavilion**

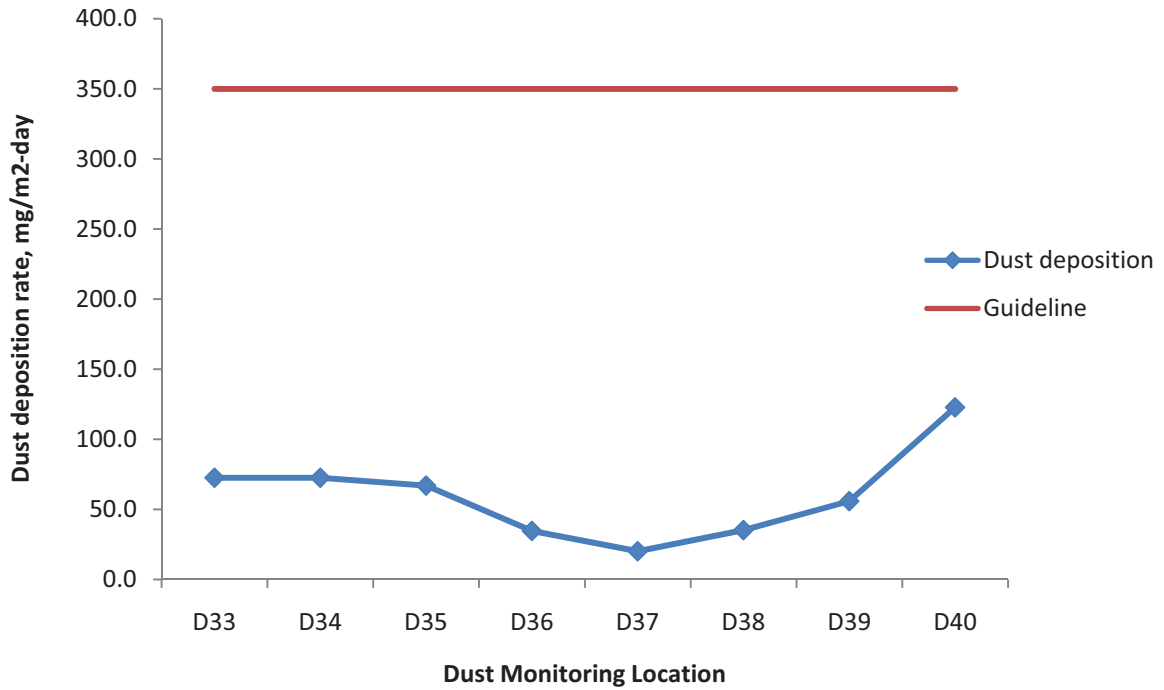
**Figure 2(h) Dust deposition monitoring, Sept - Oct 2009
Seatown Road Roundabout**

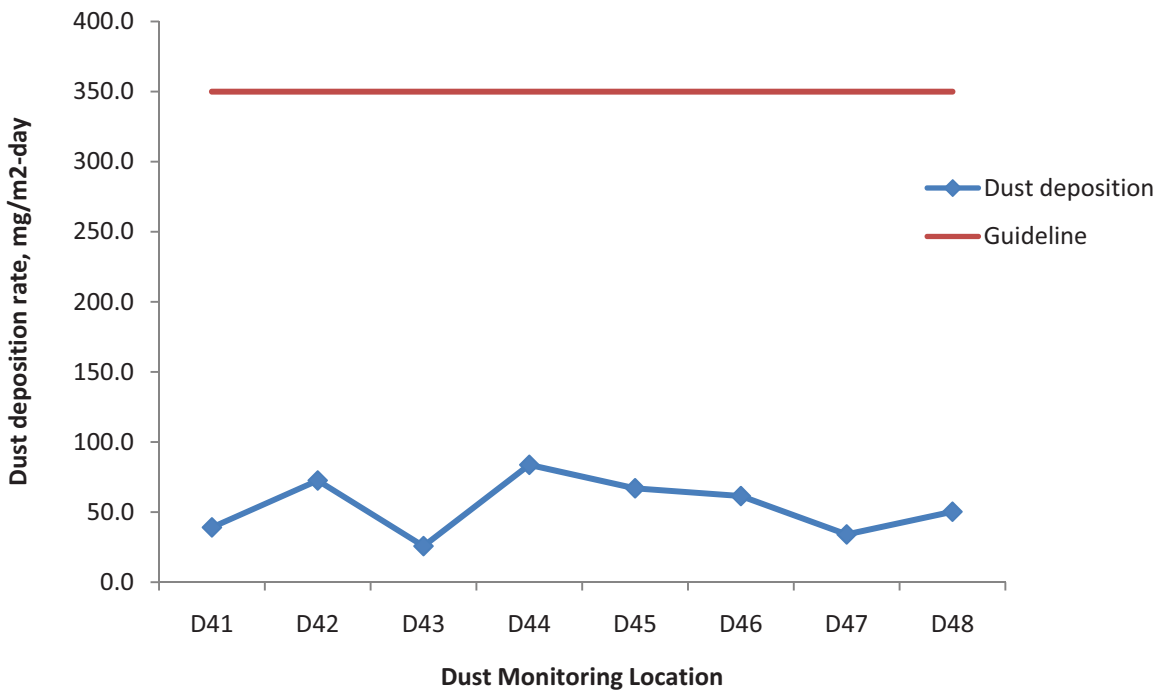
**Figure 2(i) Dust deposition monitoring, Sept - Oct 2009
Belinstown**

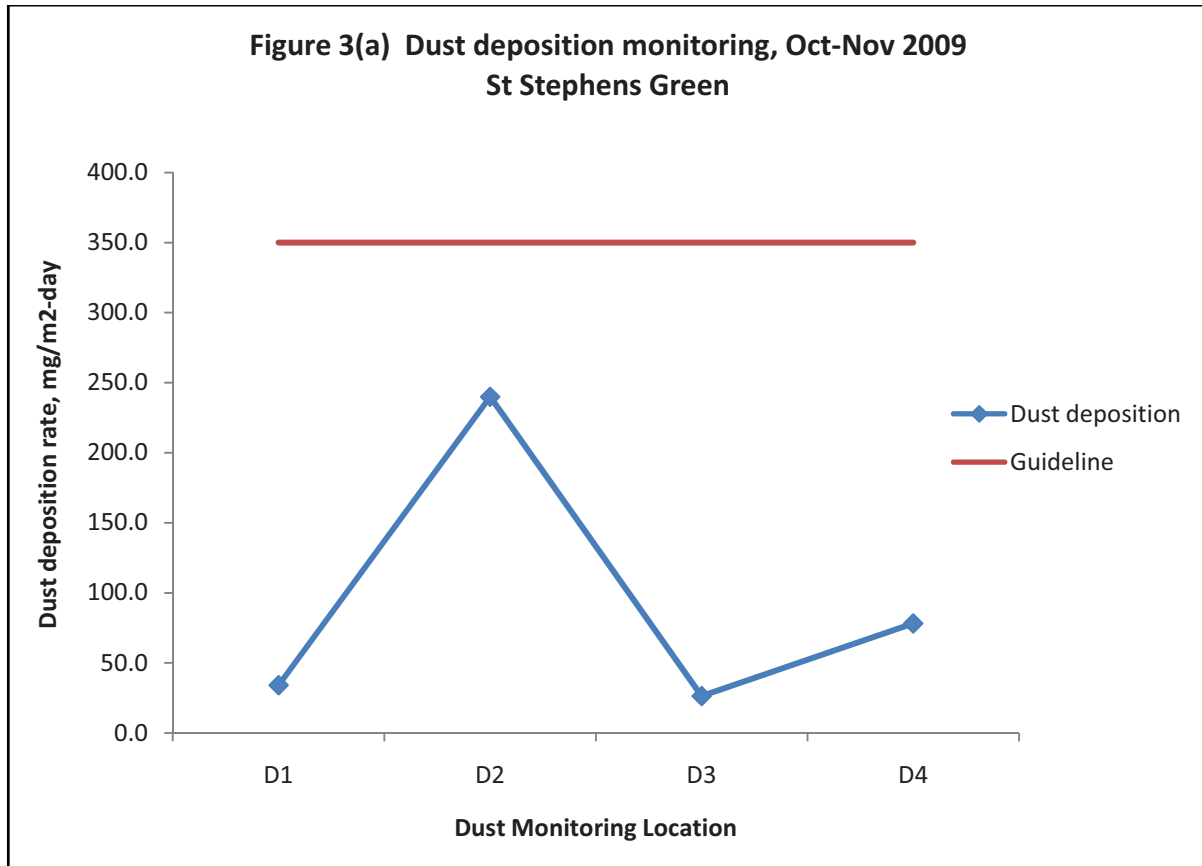
Graphs 3(a) to 3(i) provide details of the dust deposition levels at all locations (on a monthly basis) during Interval #3

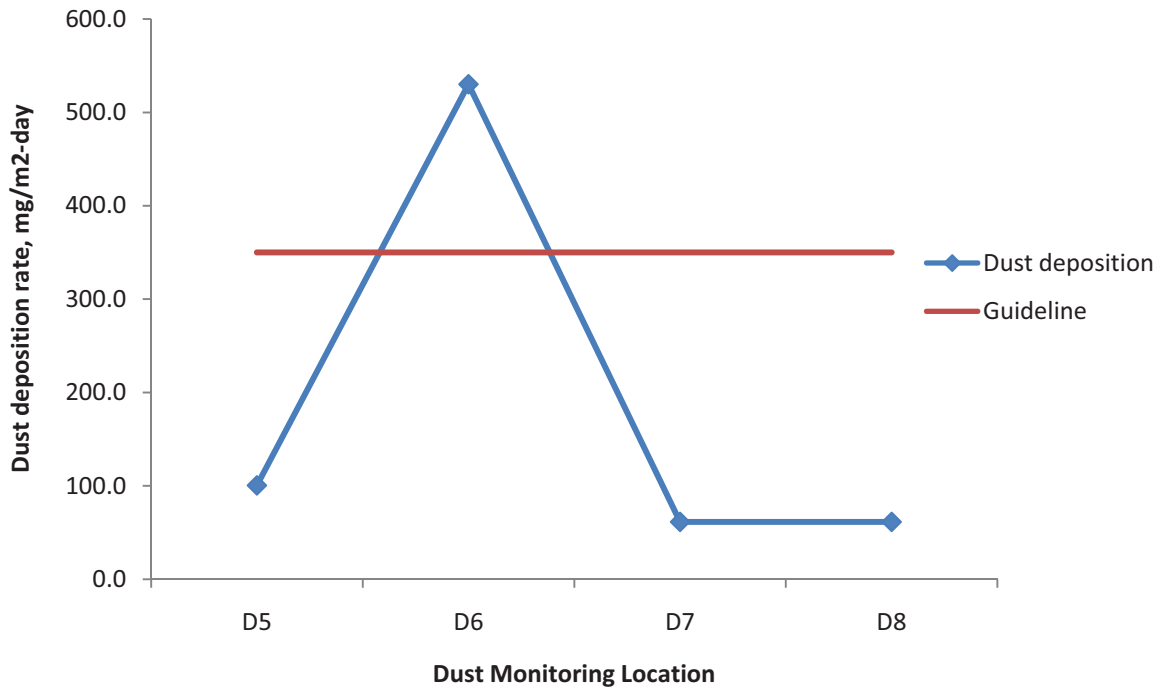
**Figure 3(b) Dust deposition monitoring, Oct-Nov 2009
Parnell Square**

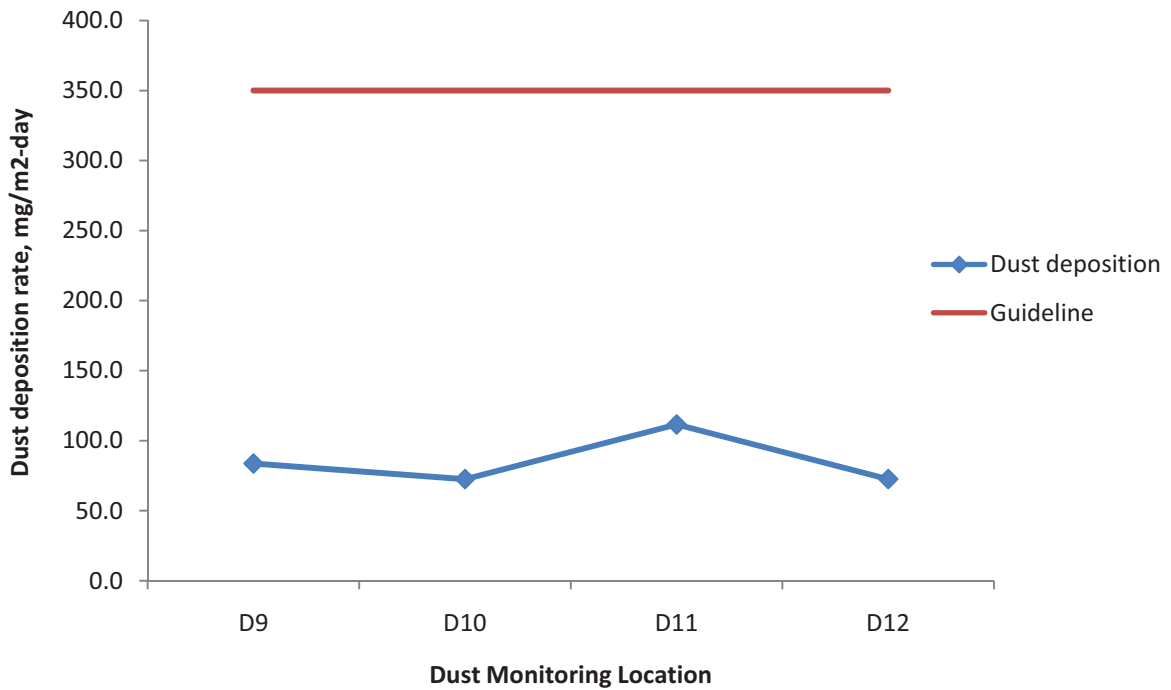
**Figure 3(c) Dust deposition monitoring, Oct-Nov 2009
Mater Hospital**

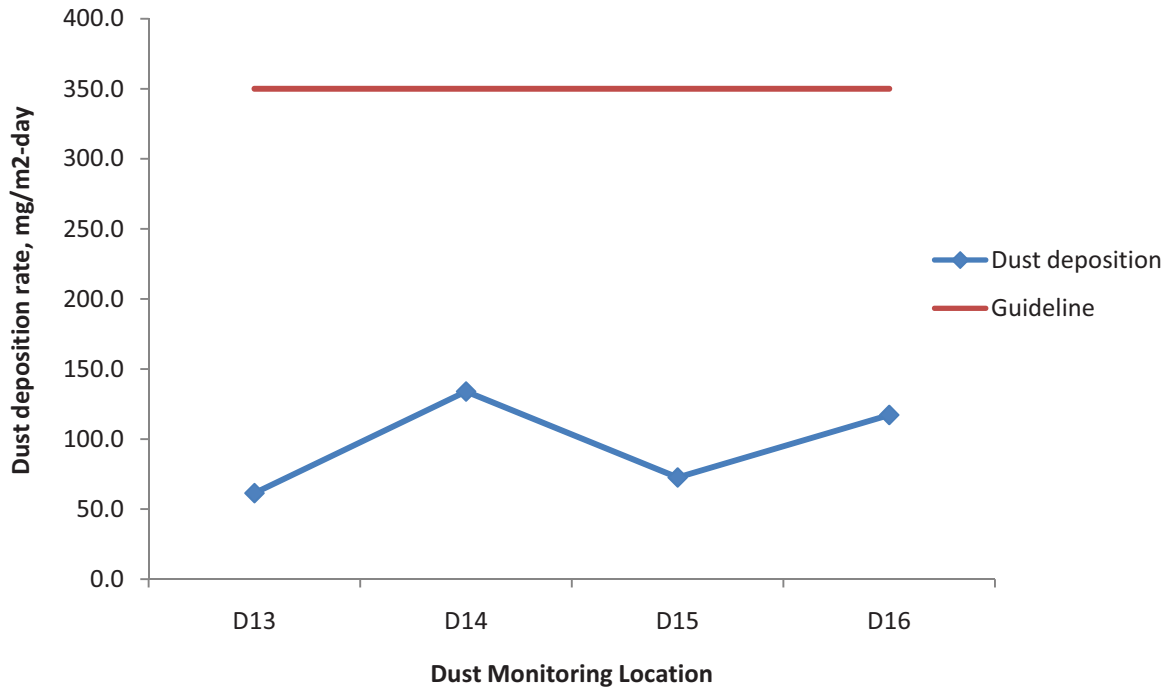
**Figure 3(d) Dust deposition monitoring, Oct-Nov 2009
Home Farm Road Drumcondra**

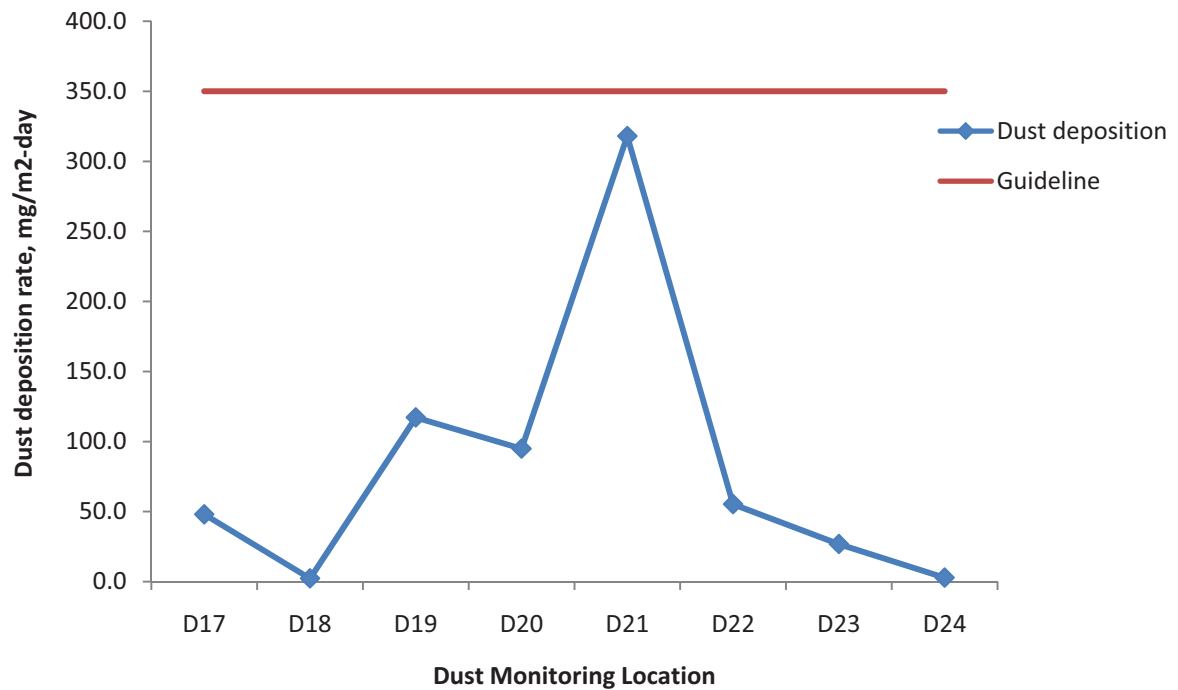
**Figure 3(e) Dust deposition monitoring, Oct-Nov 2009
Albert College Park**

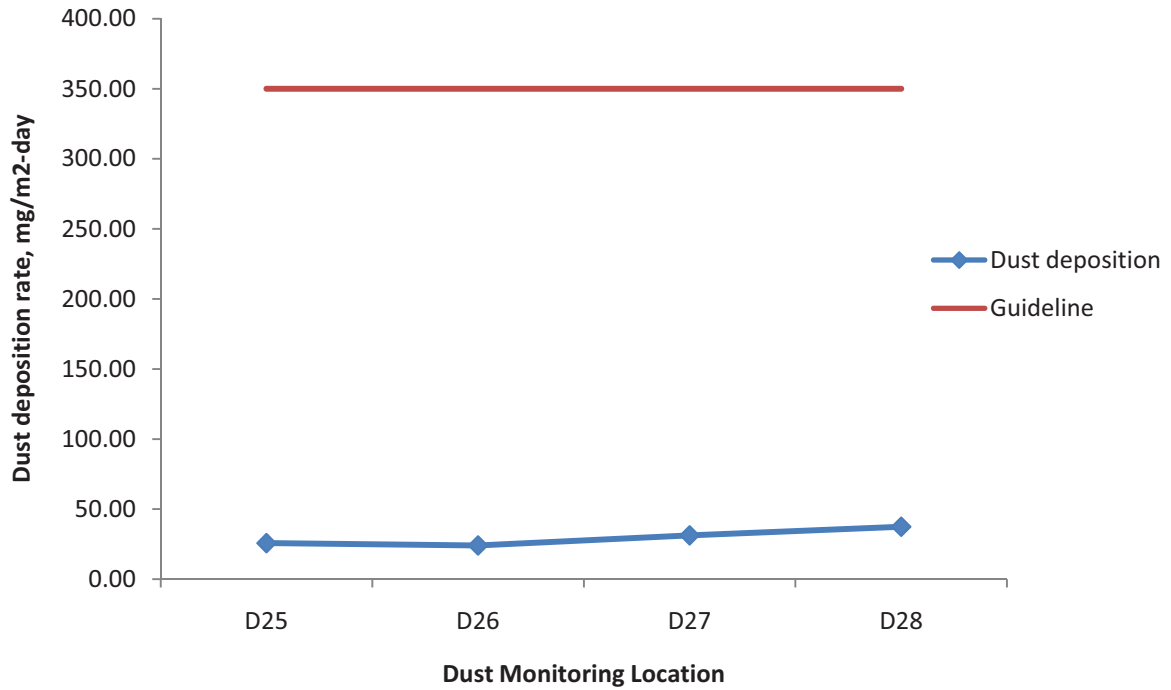
**Figure 3(f) Dust deposition monitoring, Oct-Nov 2009
Albert College Estate**

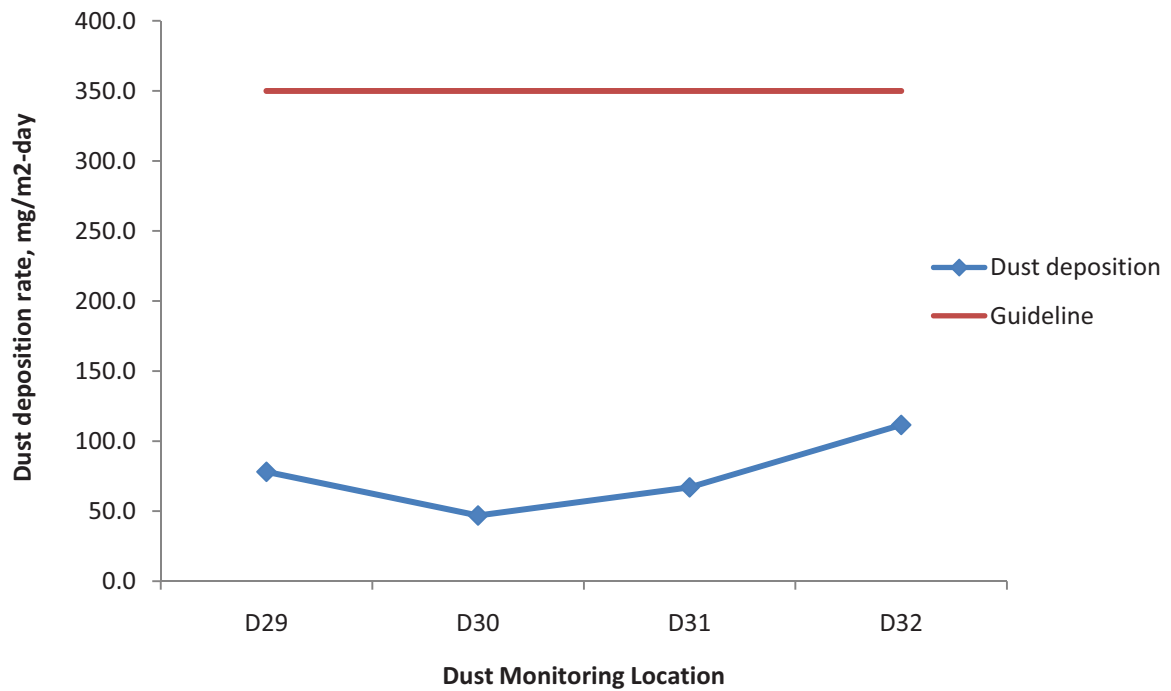
**Figure 3(g) Dust deposition monitoring Oct-Nov 2009
Swords Pavilion**

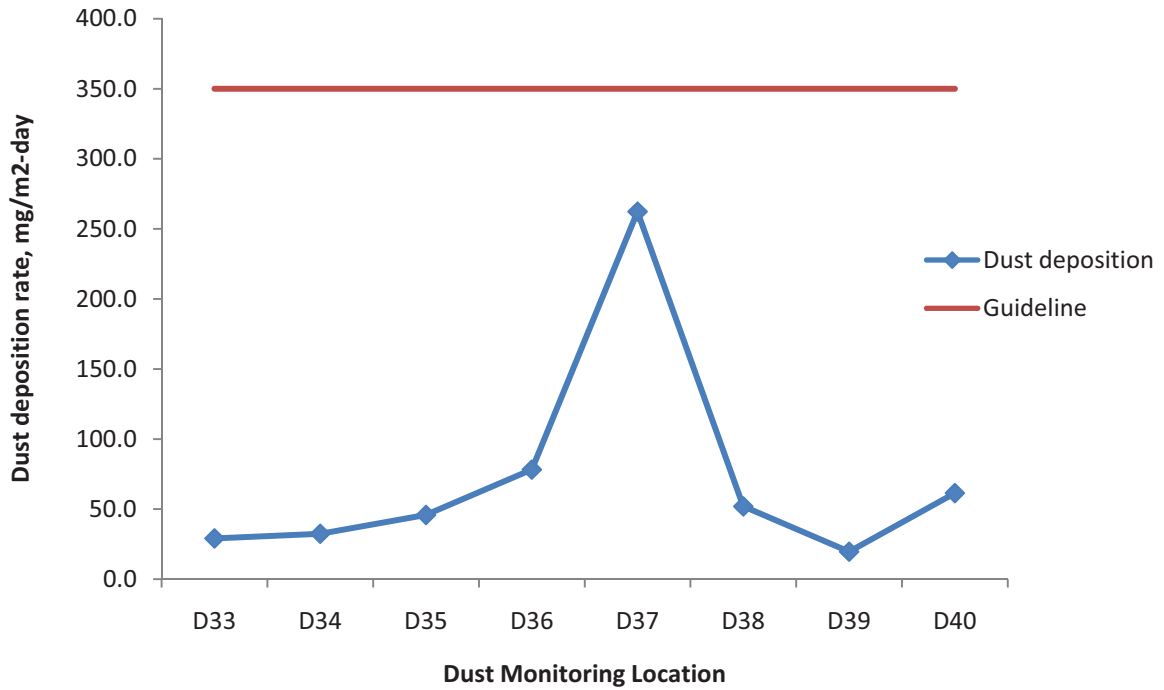
**Figure 3(h) Dust deposition monitoring, Oct-Nov 2009
Seatown Road Roundabout**

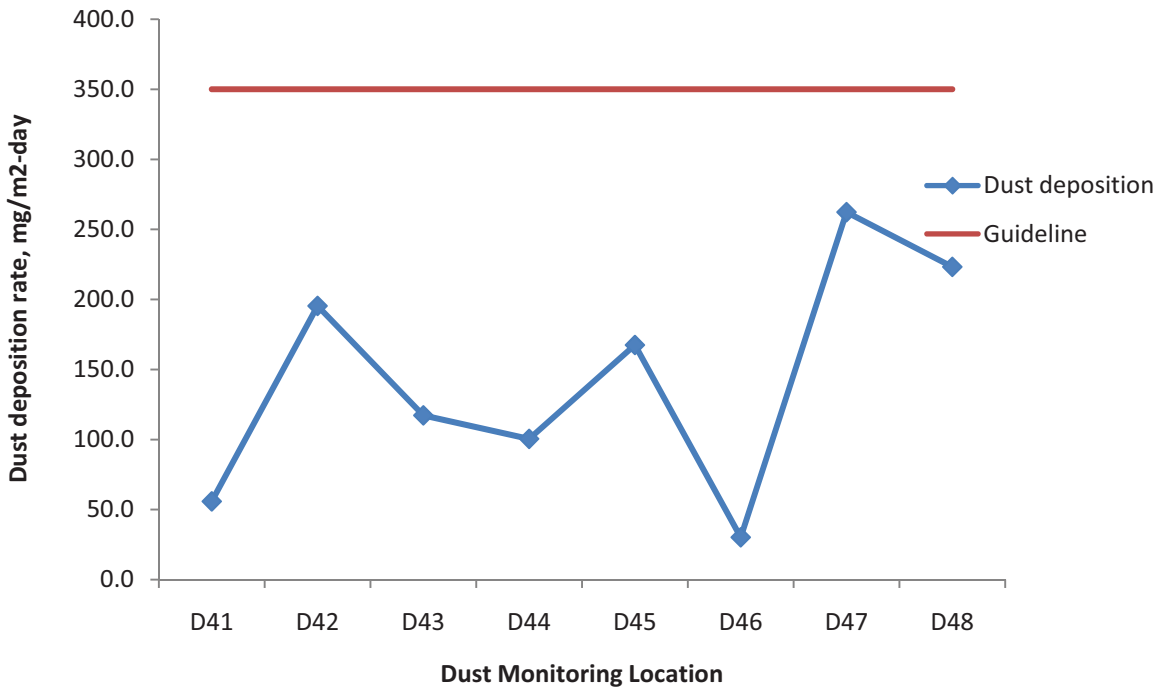
**Figure 3(i) Dust deposition monitoring Oct-Nov 2009
Belinstown**
