BASELINE DUST DEPOSITION SURVEY REPORT

Railway Procurement Agency
Parkgate Business Centre
Parkgate Street
Dublin 8

Report Ref. 16124
17th February 2010

This report presents the results of a dust deposition survey which was carried out at 48 sampling locations (D-1 to D-48) along the proposed Metro North alignment. Dust deposition rates have been measured over a four month period from 18th August – 16th December 2009.

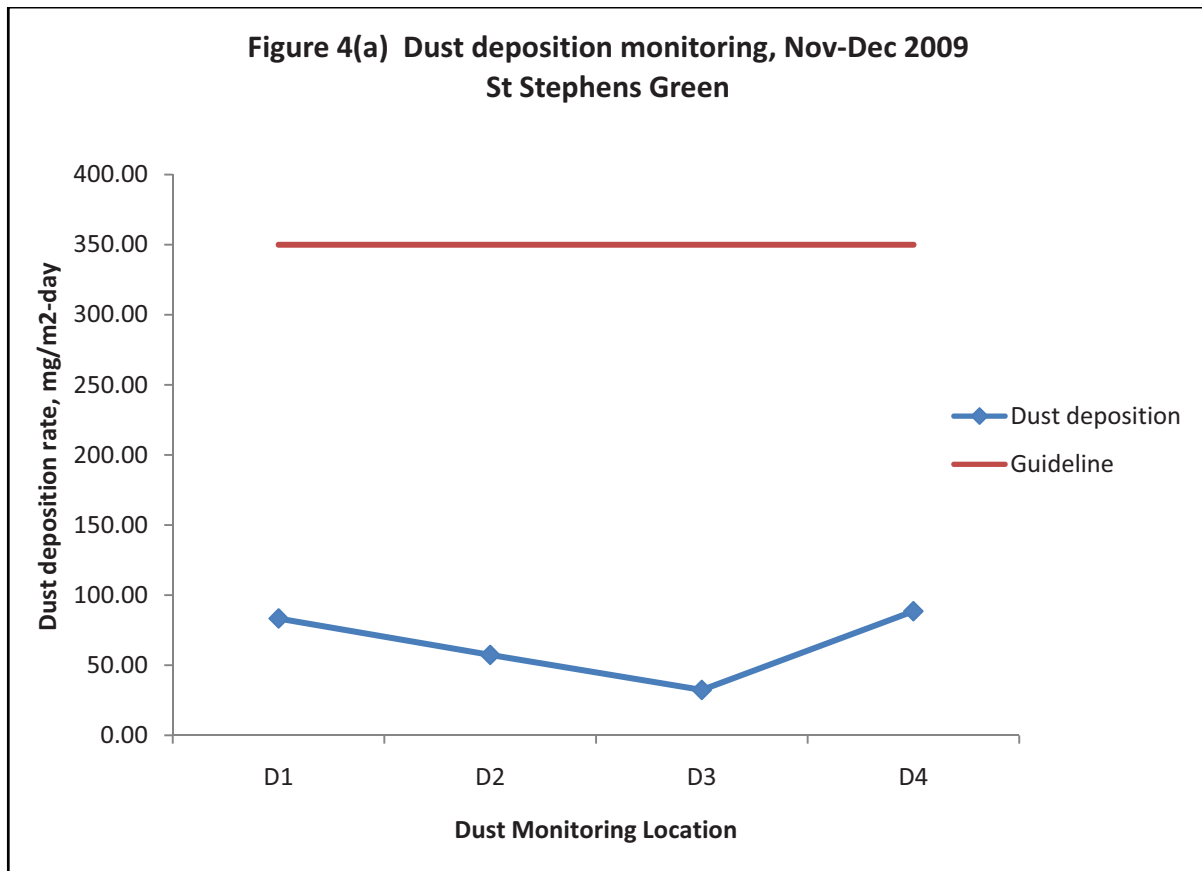
Graphs 4(a) to 4(i) provide details of the dust deposition levels at all locations (on a monthly basis) during Interval #4

- Interval #1 : Tables 2a and 2b and Figures 1(a) to 1(i)
- Interval #2 : Tables 2a and 2b and Figures 2(a) to 2(i)
- Interval #3 : Tables 2a and 2b and Figures 3(a) to 3(i)
- Interval #4 : Tables 2a and 2b and Figures 4(a) to 4(i)

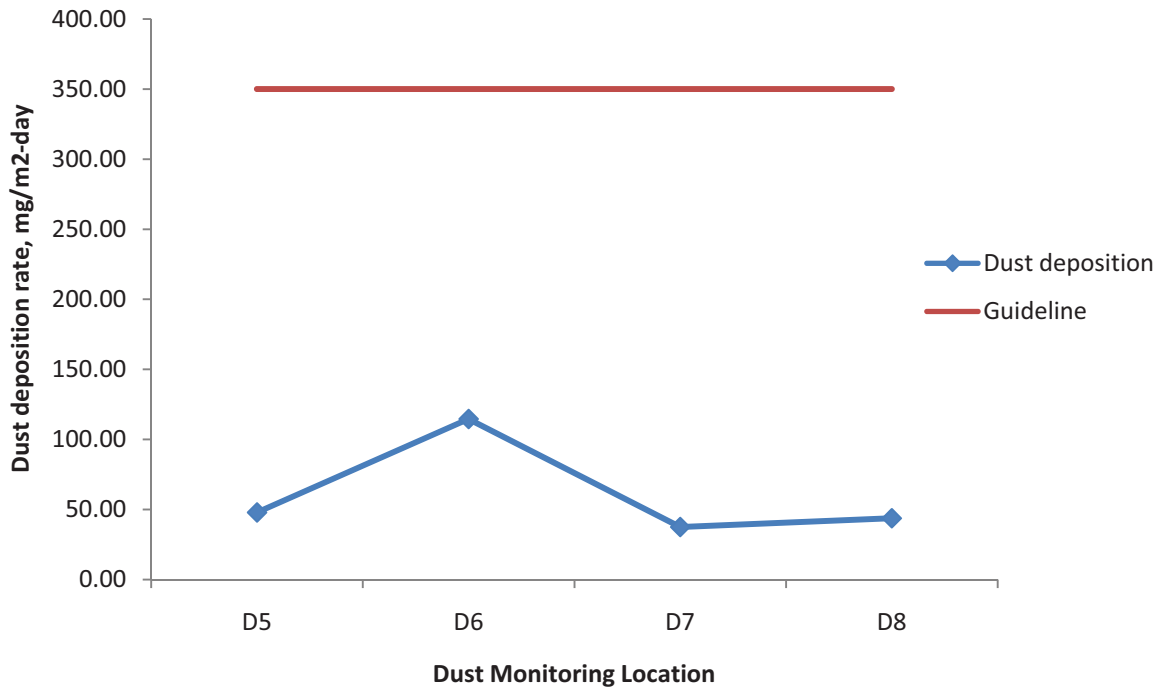
**Figure 4(b) Dust deposition monitoring, Nov-Dec 2009
Parnell Square**

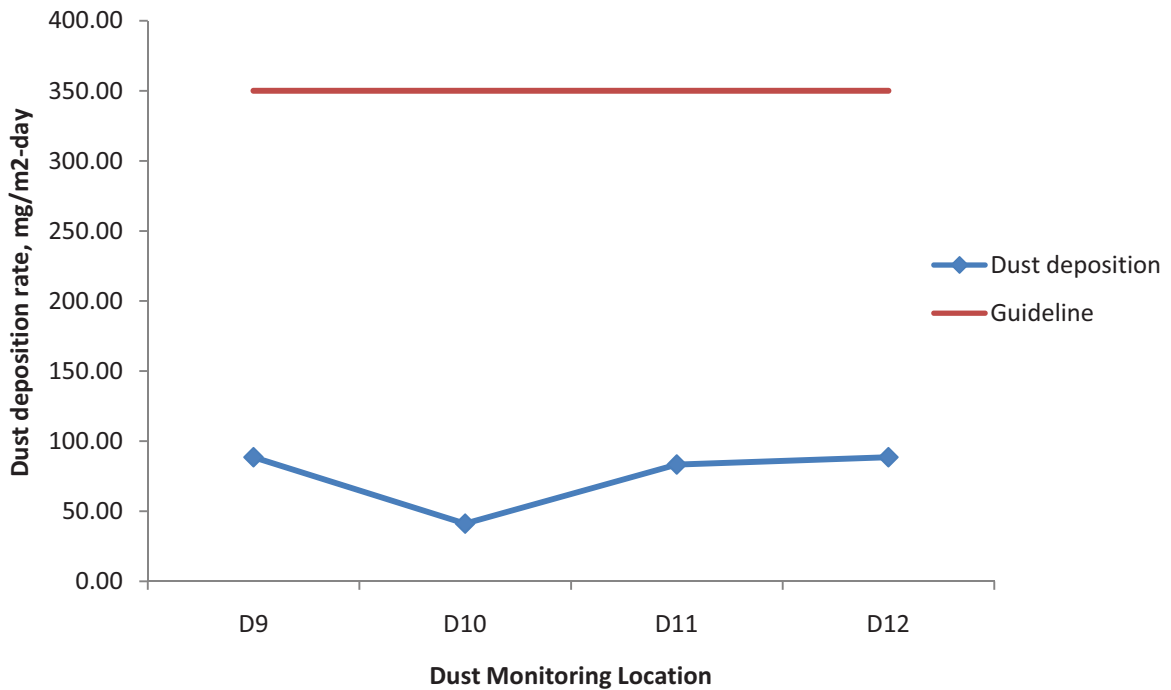
**Figure 4(c) Dust deposition monitoring, Nov-Dec 2009
Mater Hospital**

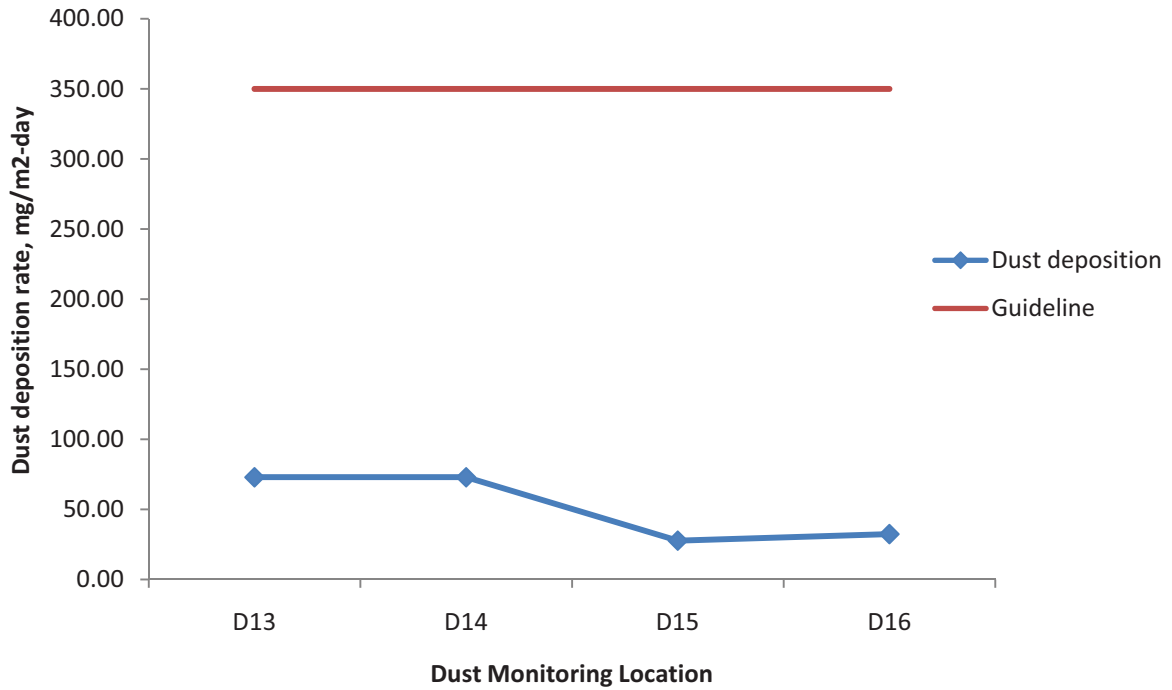
**Figure 4(d) Dust deposition monitoring, Nov-Dec 2009
Home Farm Road Drumcondra**

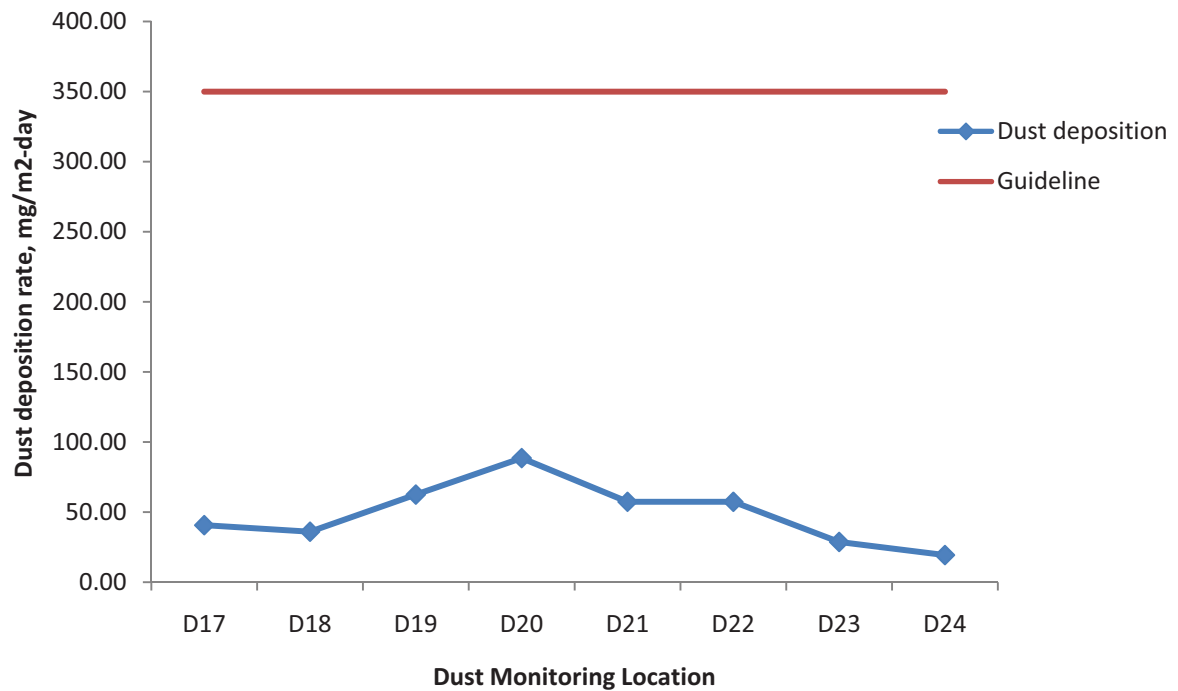
**Figure 4(e) Dust deposition monitoring, Nov-Dec 2009
Albert College Park**

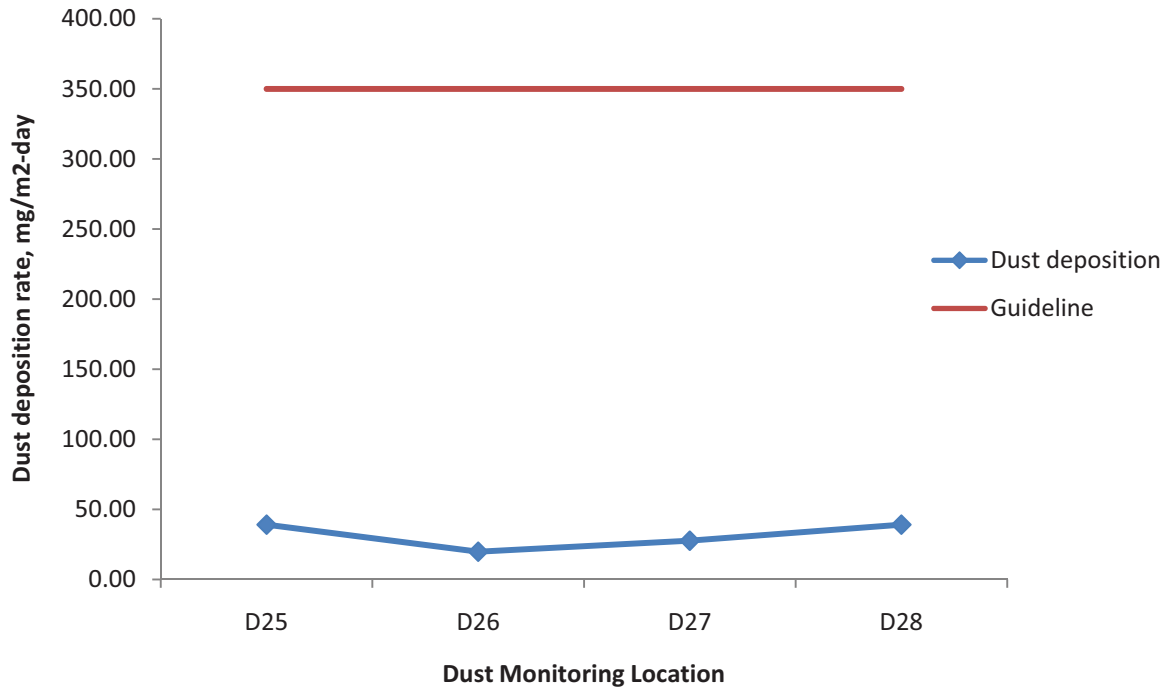
**Figure 4(f) Dust deposition monitoring, Nov-Dec 2009
Albert College Estate**

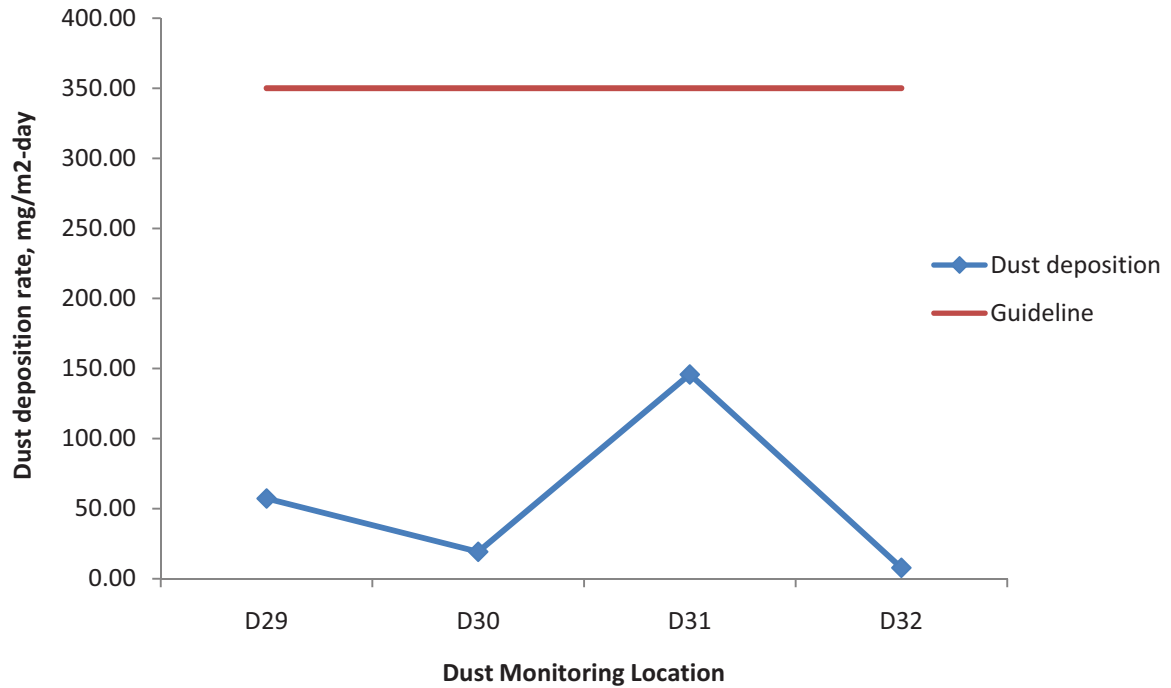
**Figure 4(g) Dust deposition monitoring Nov-Dec 2009
Swords Pavilion**

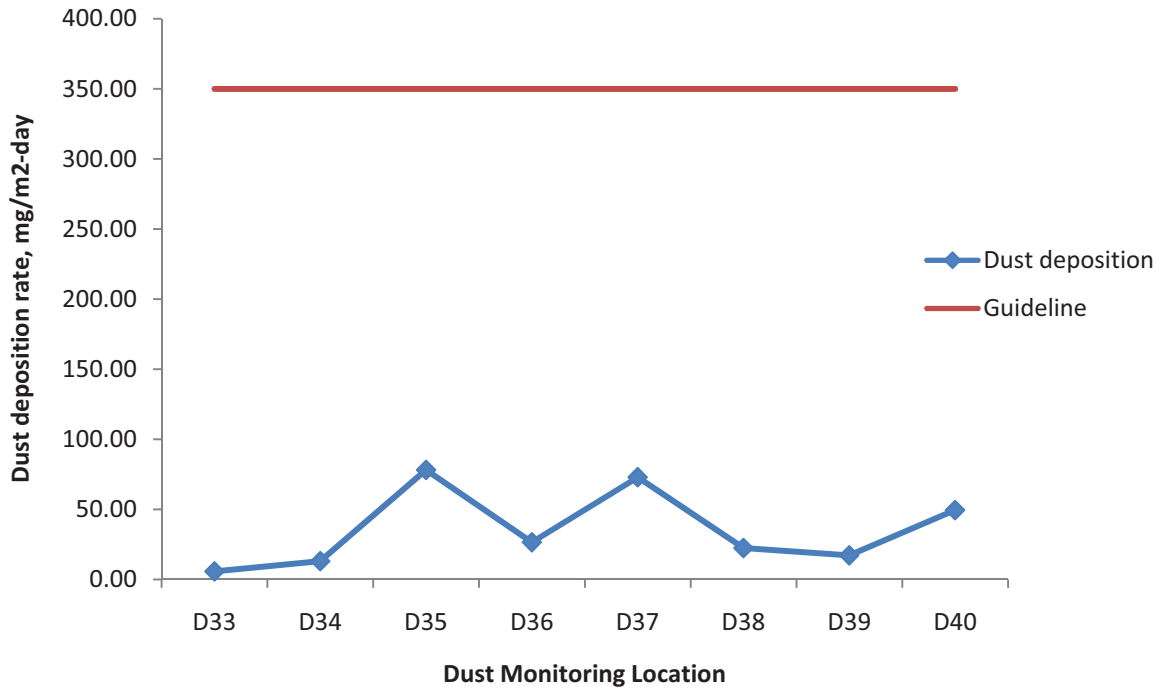
**Figure 4(h) Dust deposition monitoring, Nov-Dec 2009
Seatown Road Roundabout**

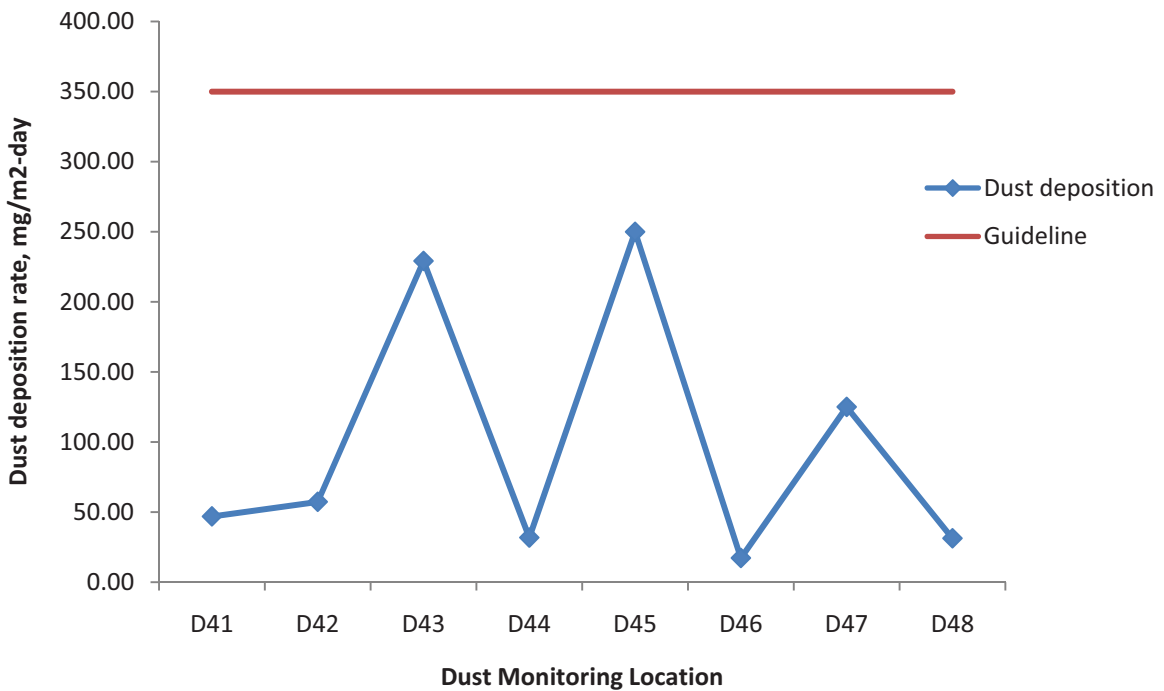
**Figure 4(i) Dust deposition monitoring Nov-Dec 2009
Belinstown**

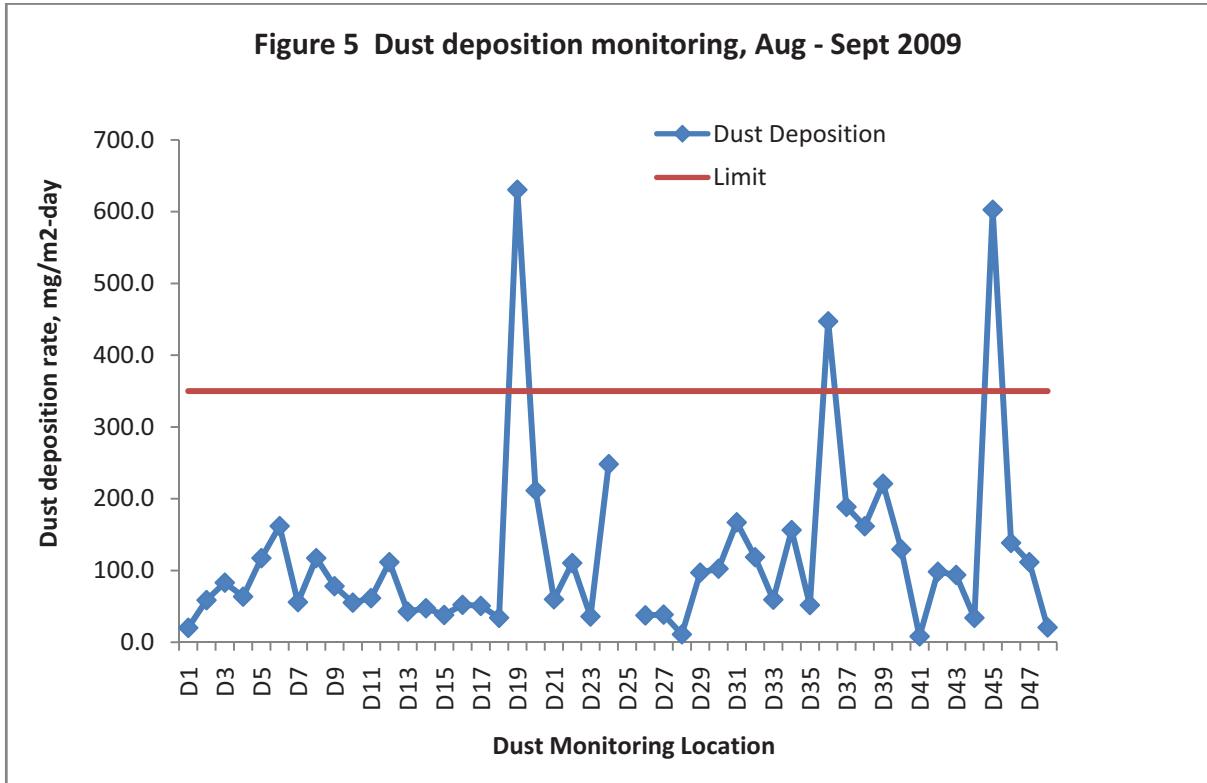
Interval #1

DUST DEPOSITION MONITORING RESULTS IN GRAPHICAL FORMAT: ALL LOCATIONS

The dust gauges were collected for analysis on 21st September 2009 for monitoring Interval #1. On this date one dust gauge, D25, was missing and therefore no result could be reported. Monitoring results for 44 of the 47 monitoring locations are well within the guideline value of $350 \text{ mg}/\text{m}^2\text{-day}$ indicating that existing air quality is reasonable with respect to dust deposition. Monitoring data for 3 of the monitoring locations exceeded the guideline value of $350 \text{ mg}/\text{m}^2\text{-day}$; this information and possible explanations for the relatively high levels of dust recorded in these locations is summarized in Tables 3a.

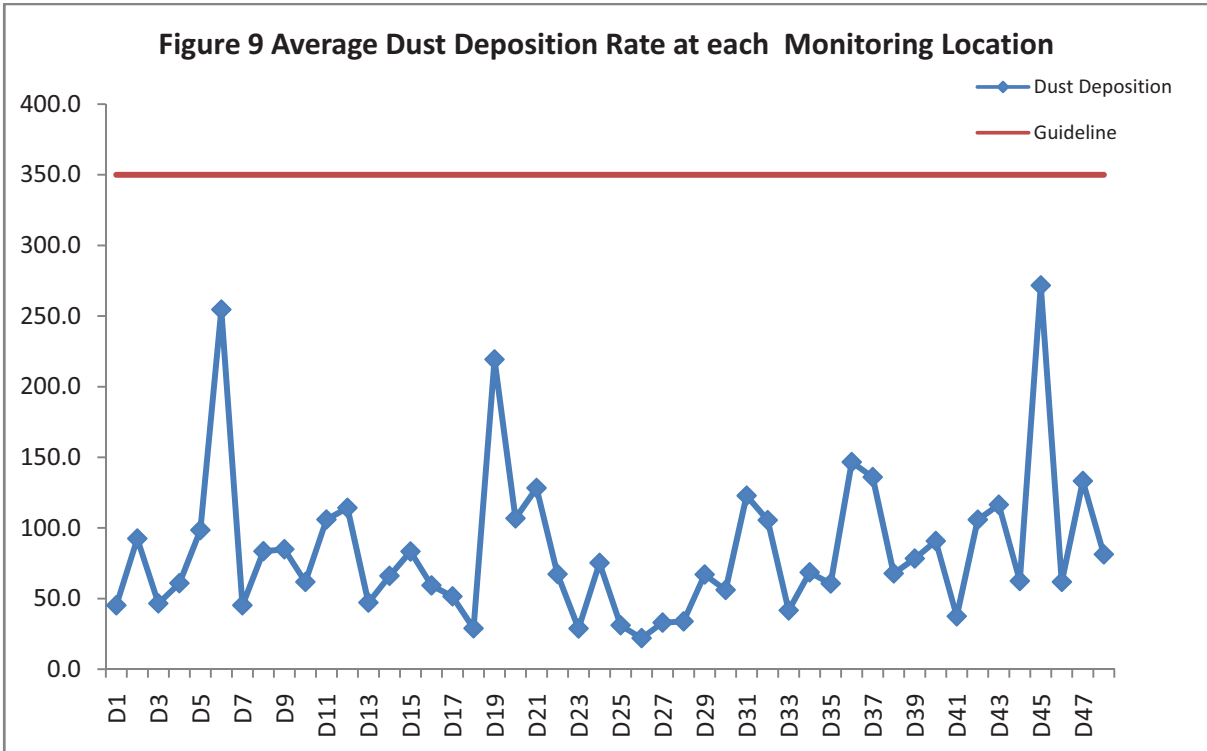
AVERAGE DUST DEPOSITION RATE AT EACH MONITORING LOCATION: INTERVALS #1 - #4

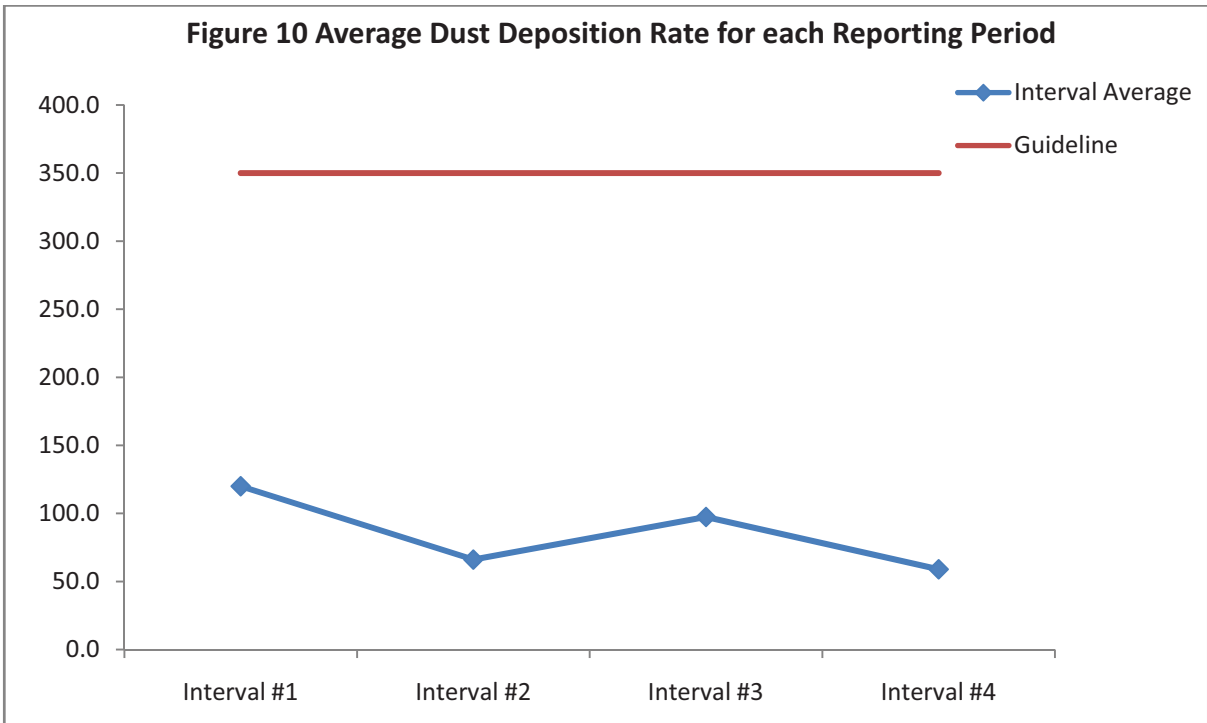
AVERAGE DUST DEPOSITION RATE FOR EACH REPORTING PERIOD

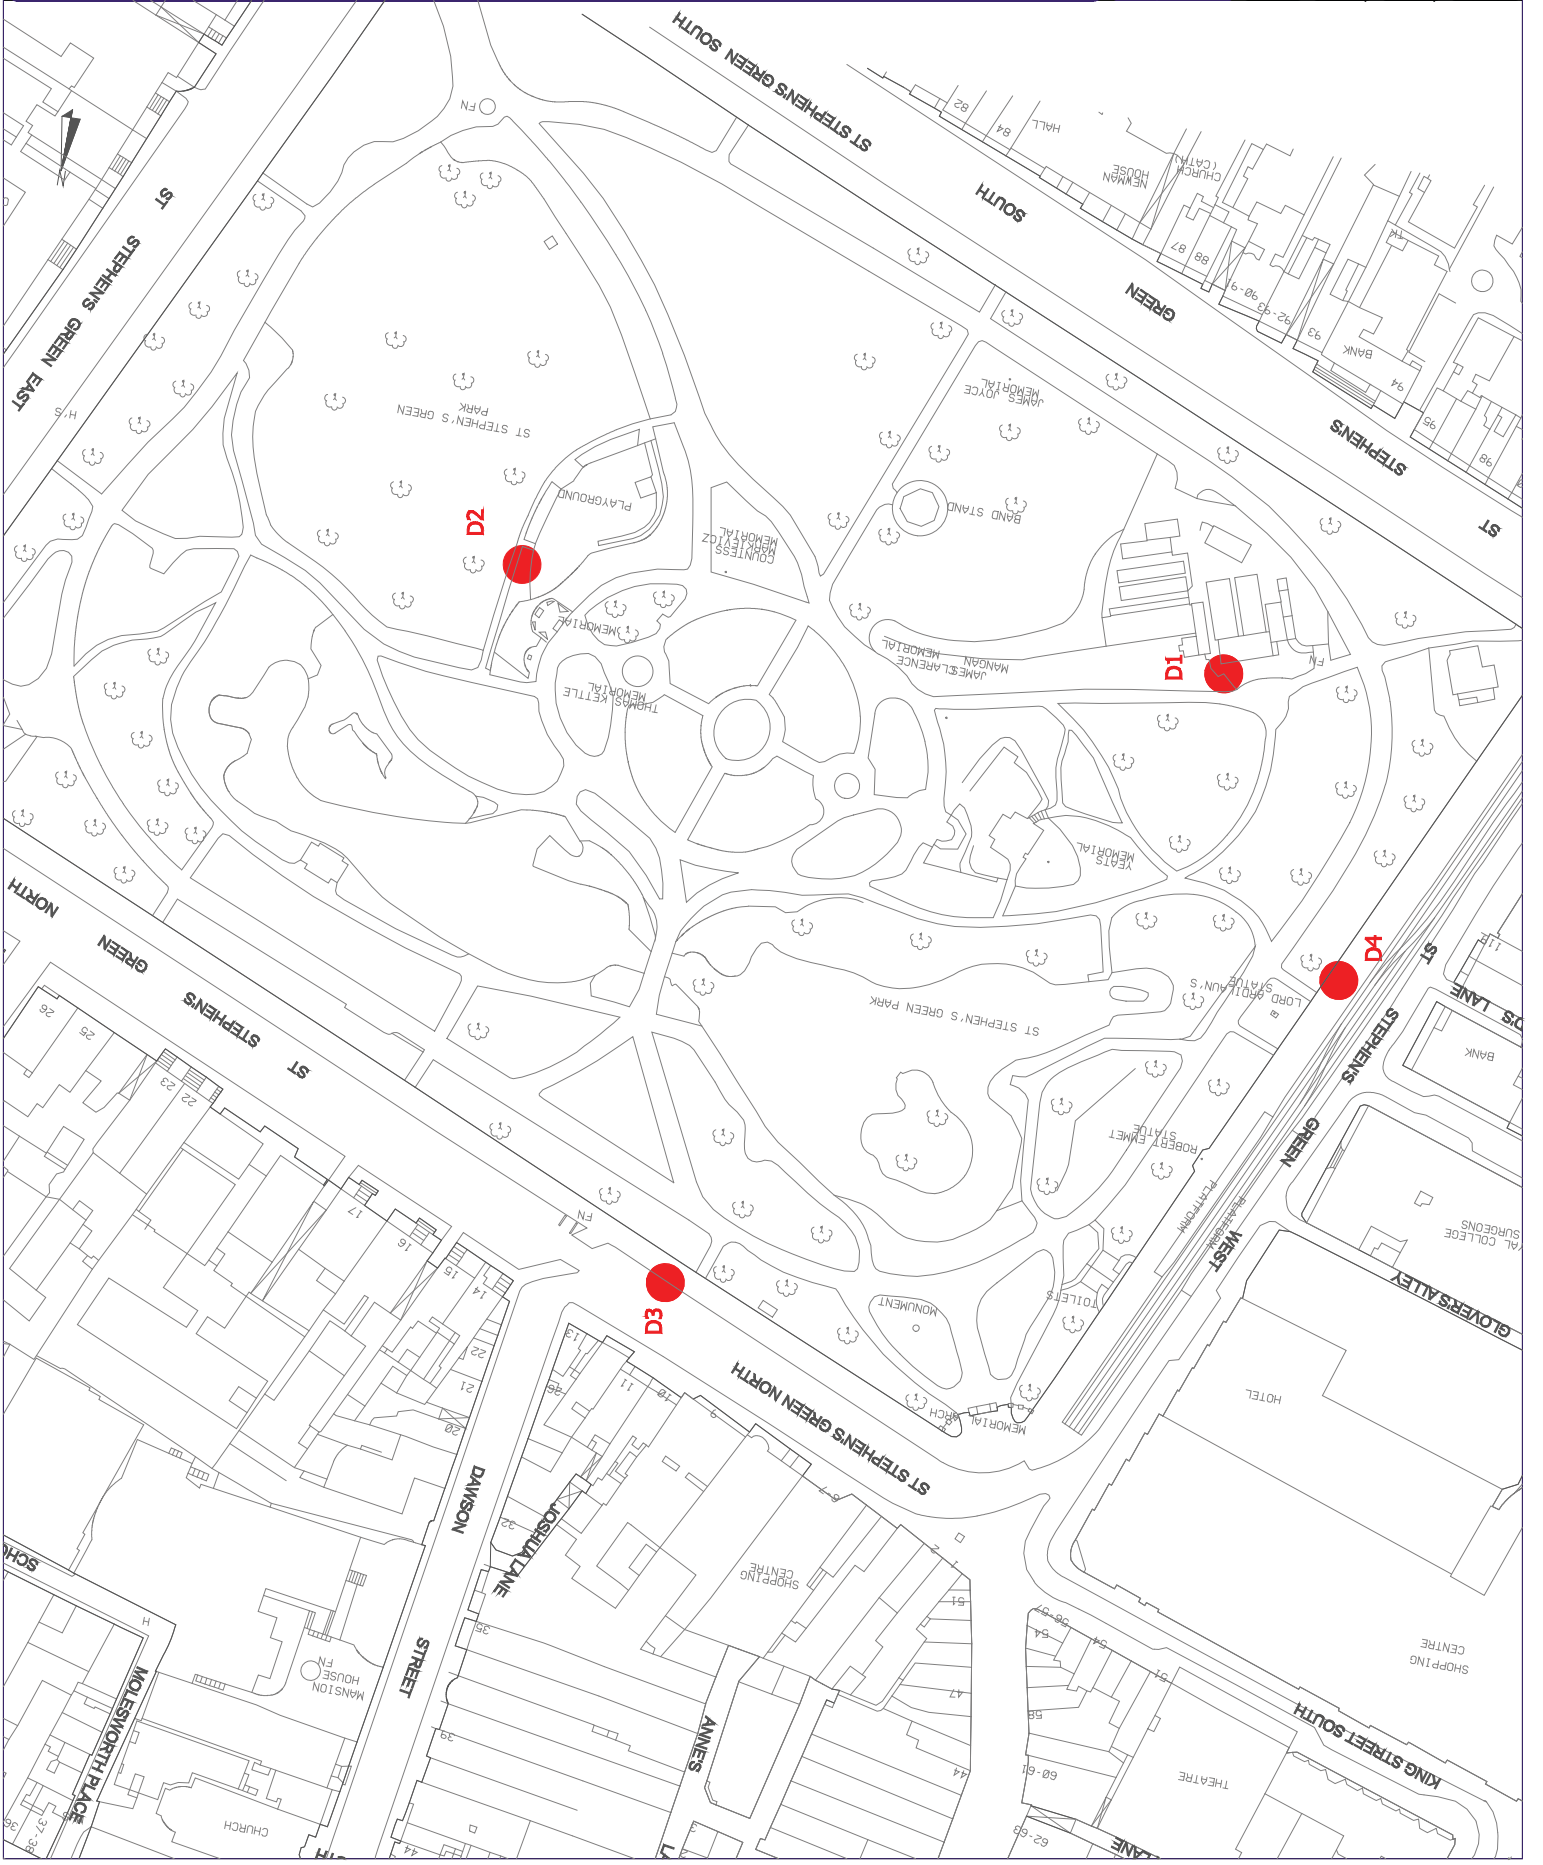
Dwg No.:	TMS-AMQ001	Project No.:	15691
Scale:	1:1000 AT A2	Drawn By:	TC
Date:	27TH JAN 2010	Checked By:	PB

Title: SAMPLING POINT LOCATION MAP:
ST. STEPHEN'S GREEN

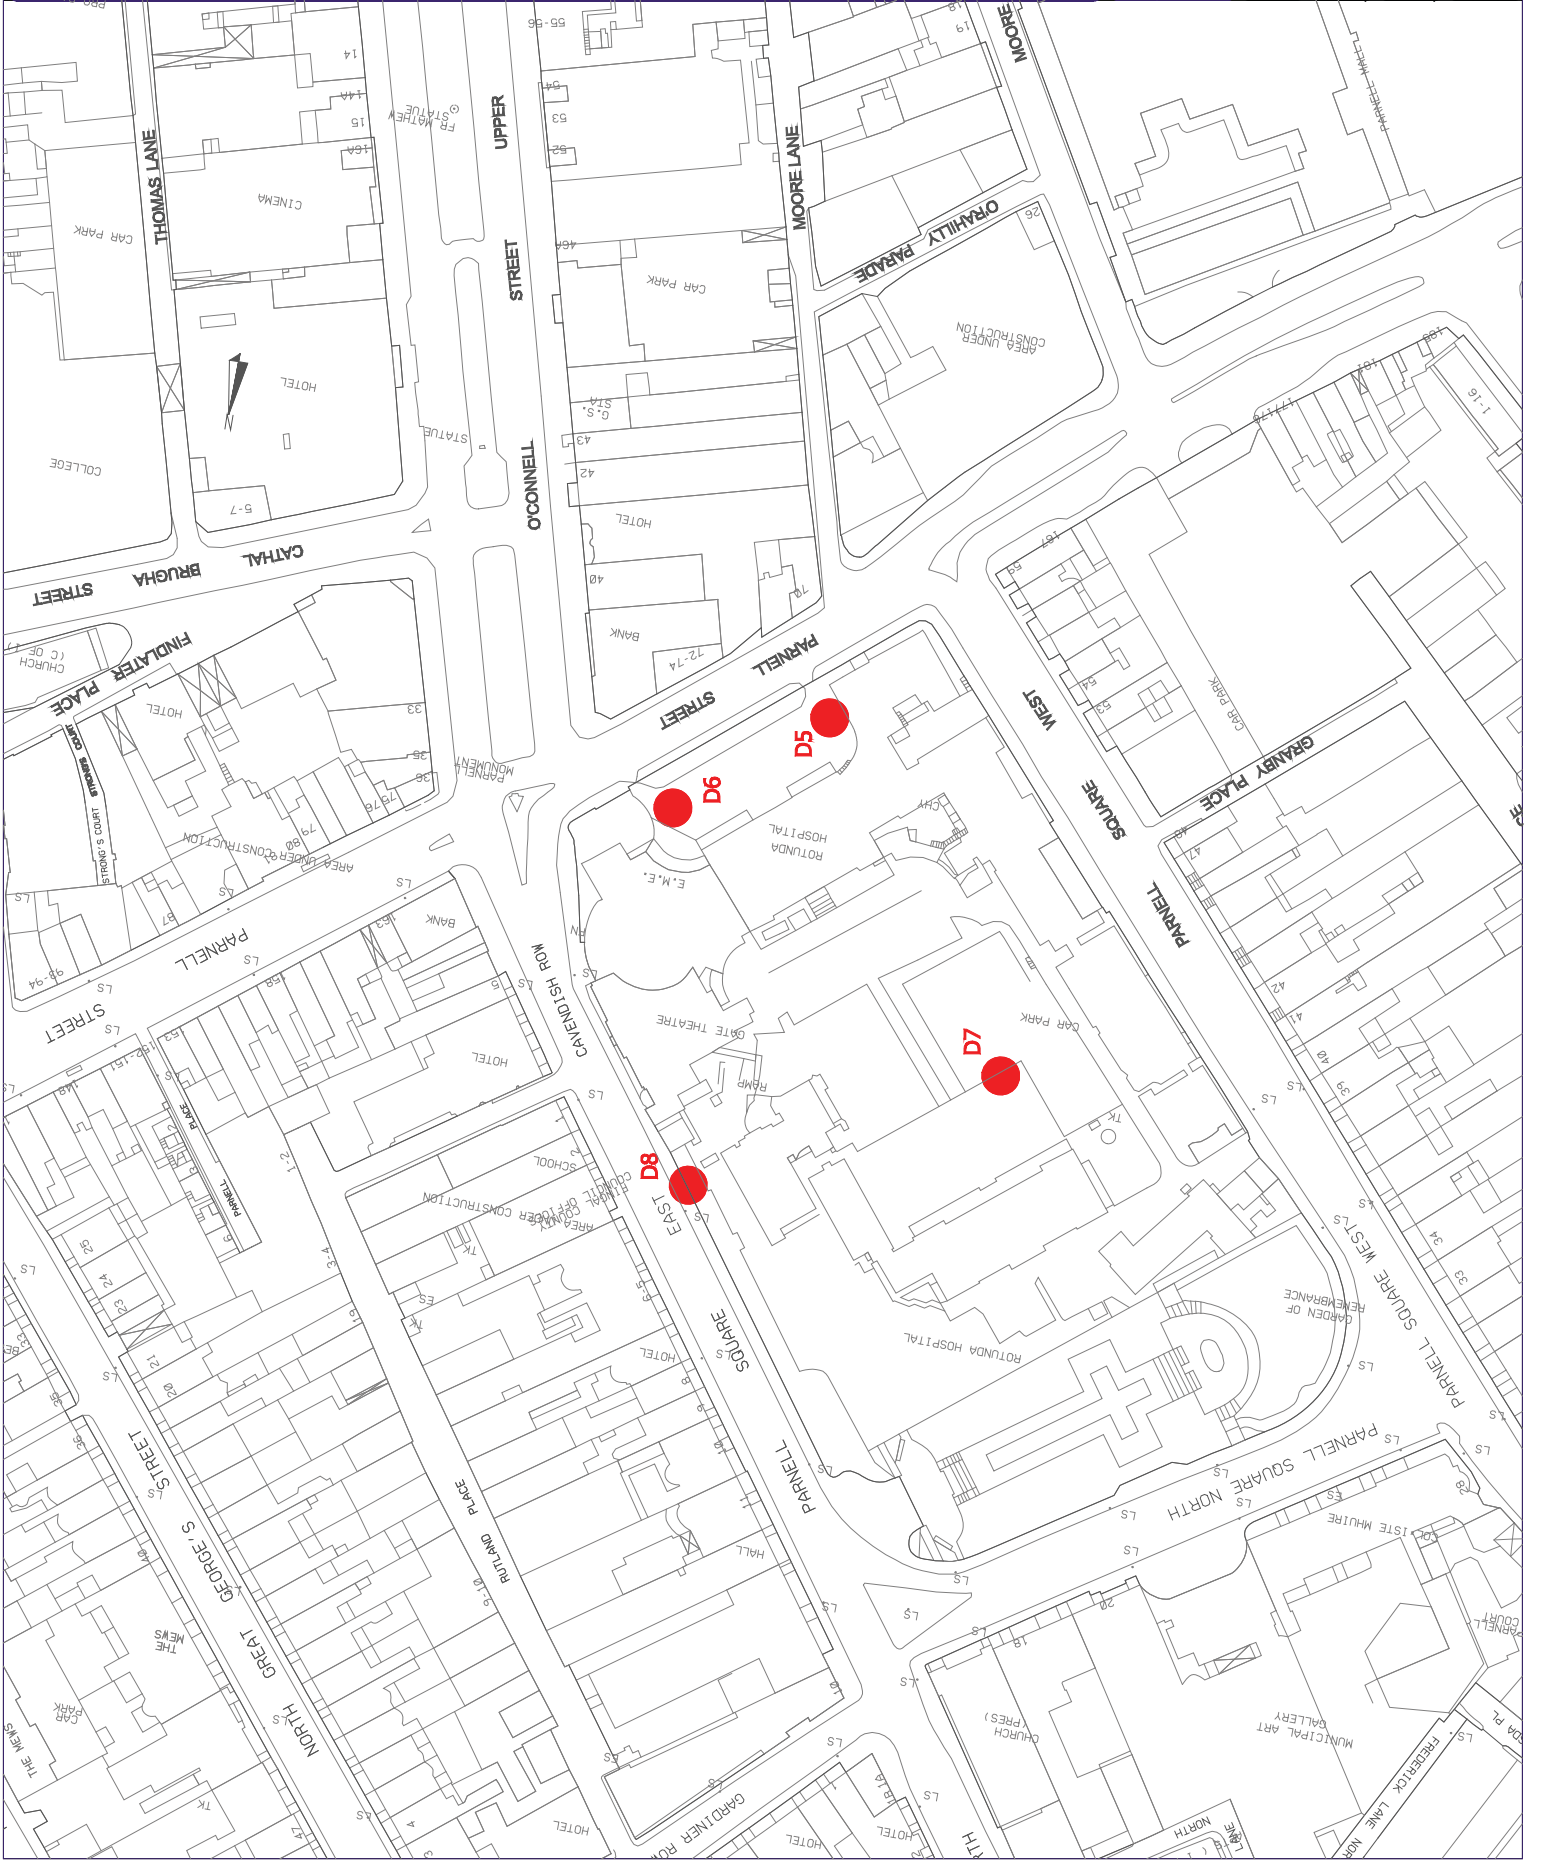
Dwg No.: TMS-MN002
Scale: 1:1000 AT A2
Date: 27TH JAN 2010

Title: SAMPLING POINT LOCATION MAP:
 PARNELL SQ.

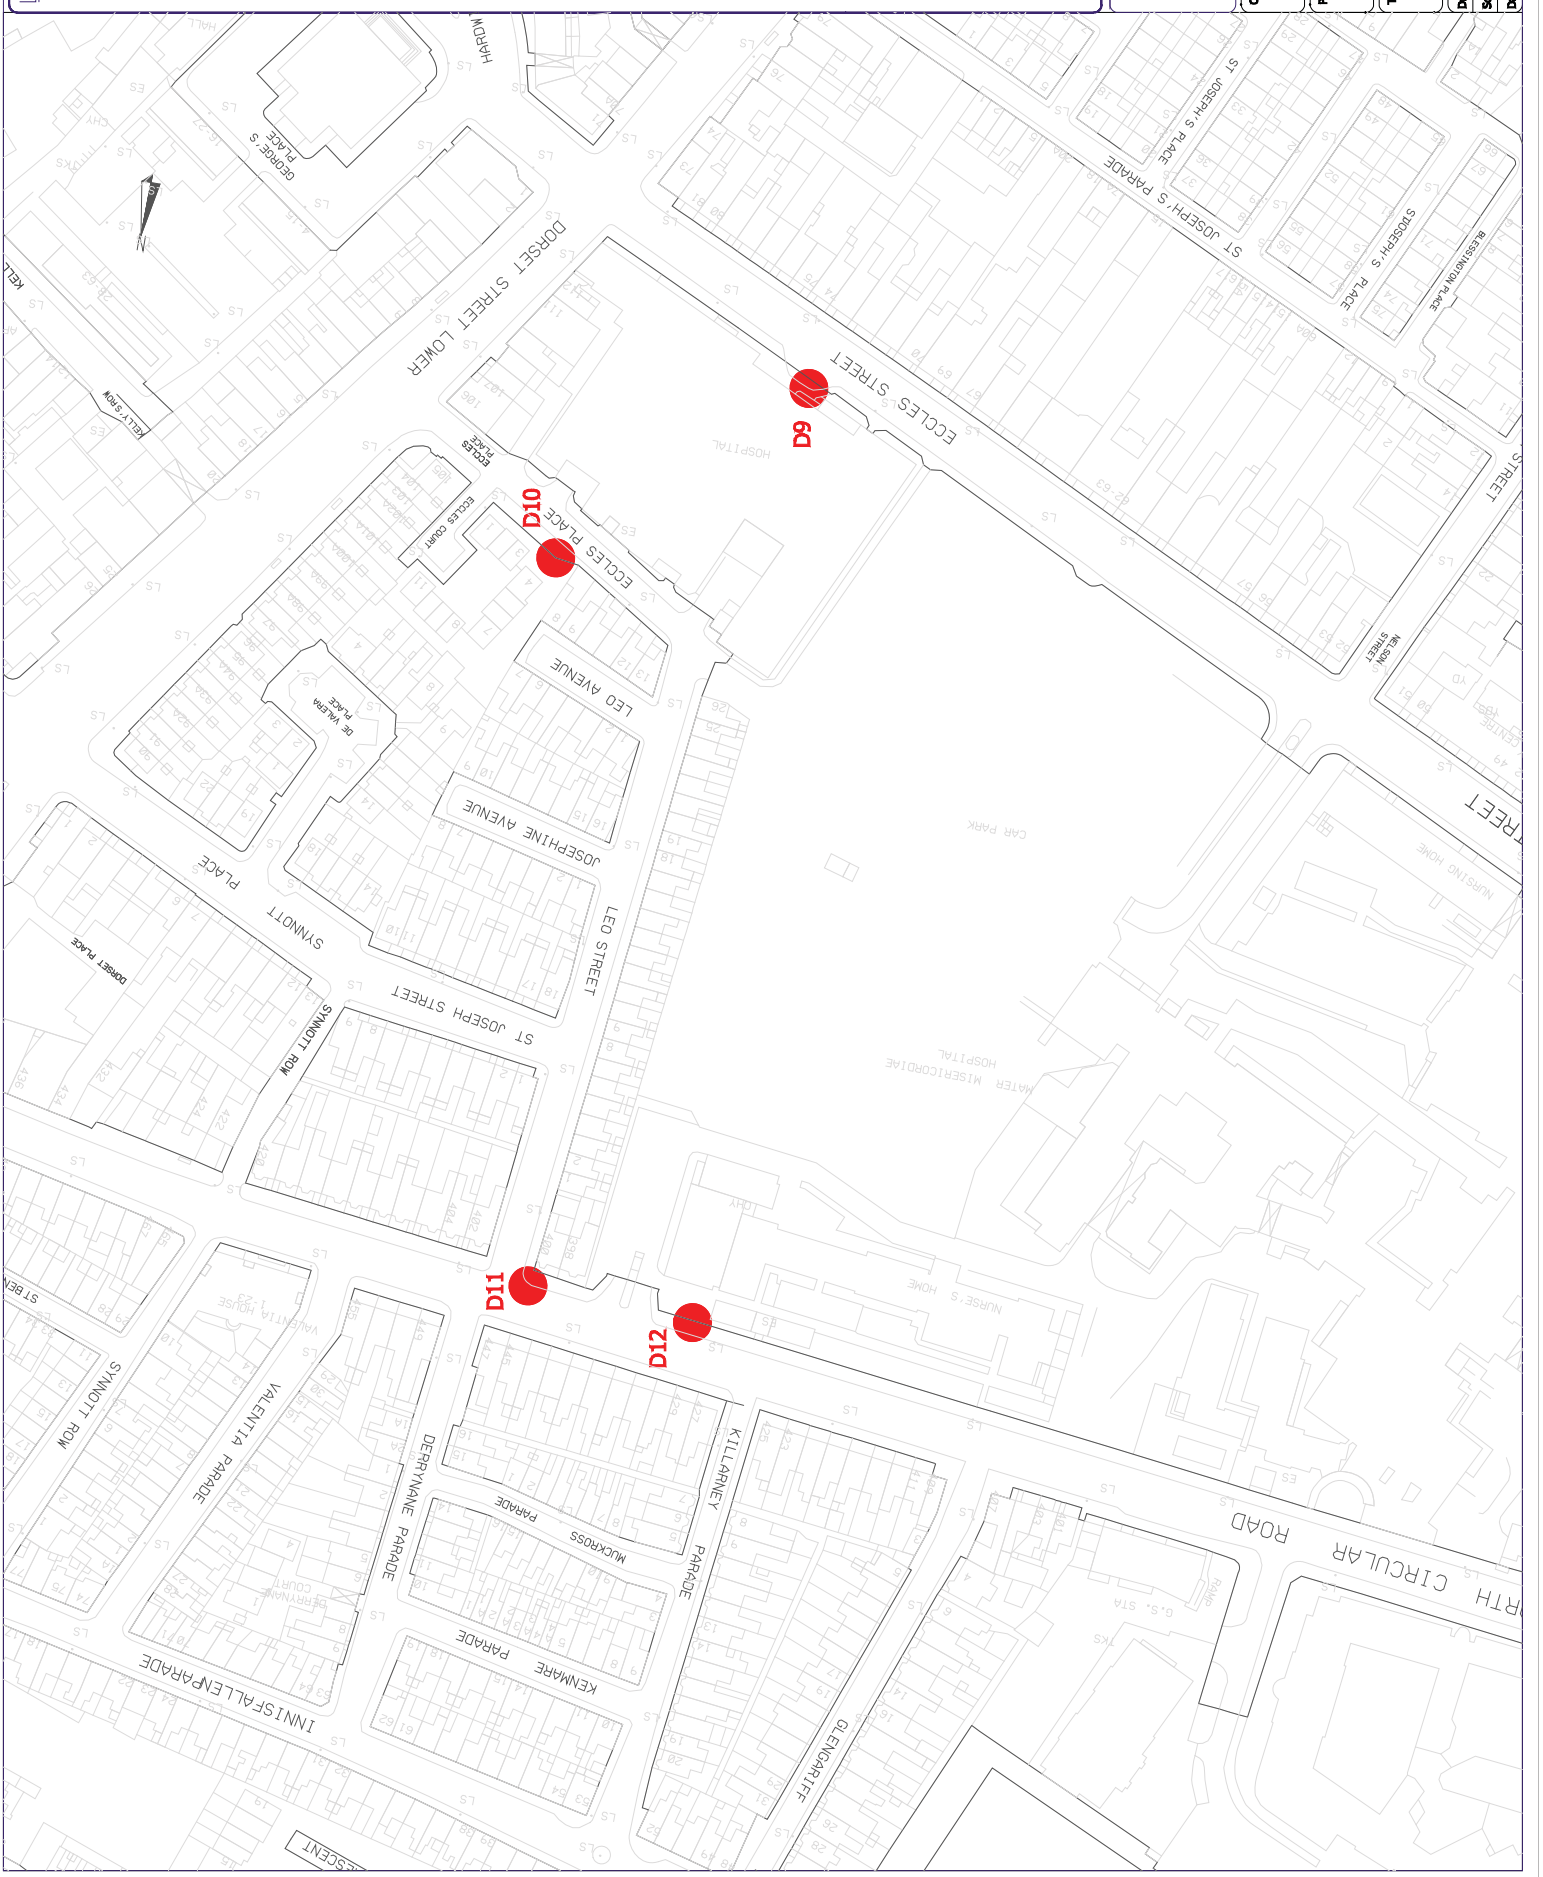
Dwg No: TMS-MN003
 Scale: 1:1000 AT A2
 Date: 27TH JAN 2010

TITLE: **SAMPLING POINT LOCATION MAP: WATER HOSPITAL**

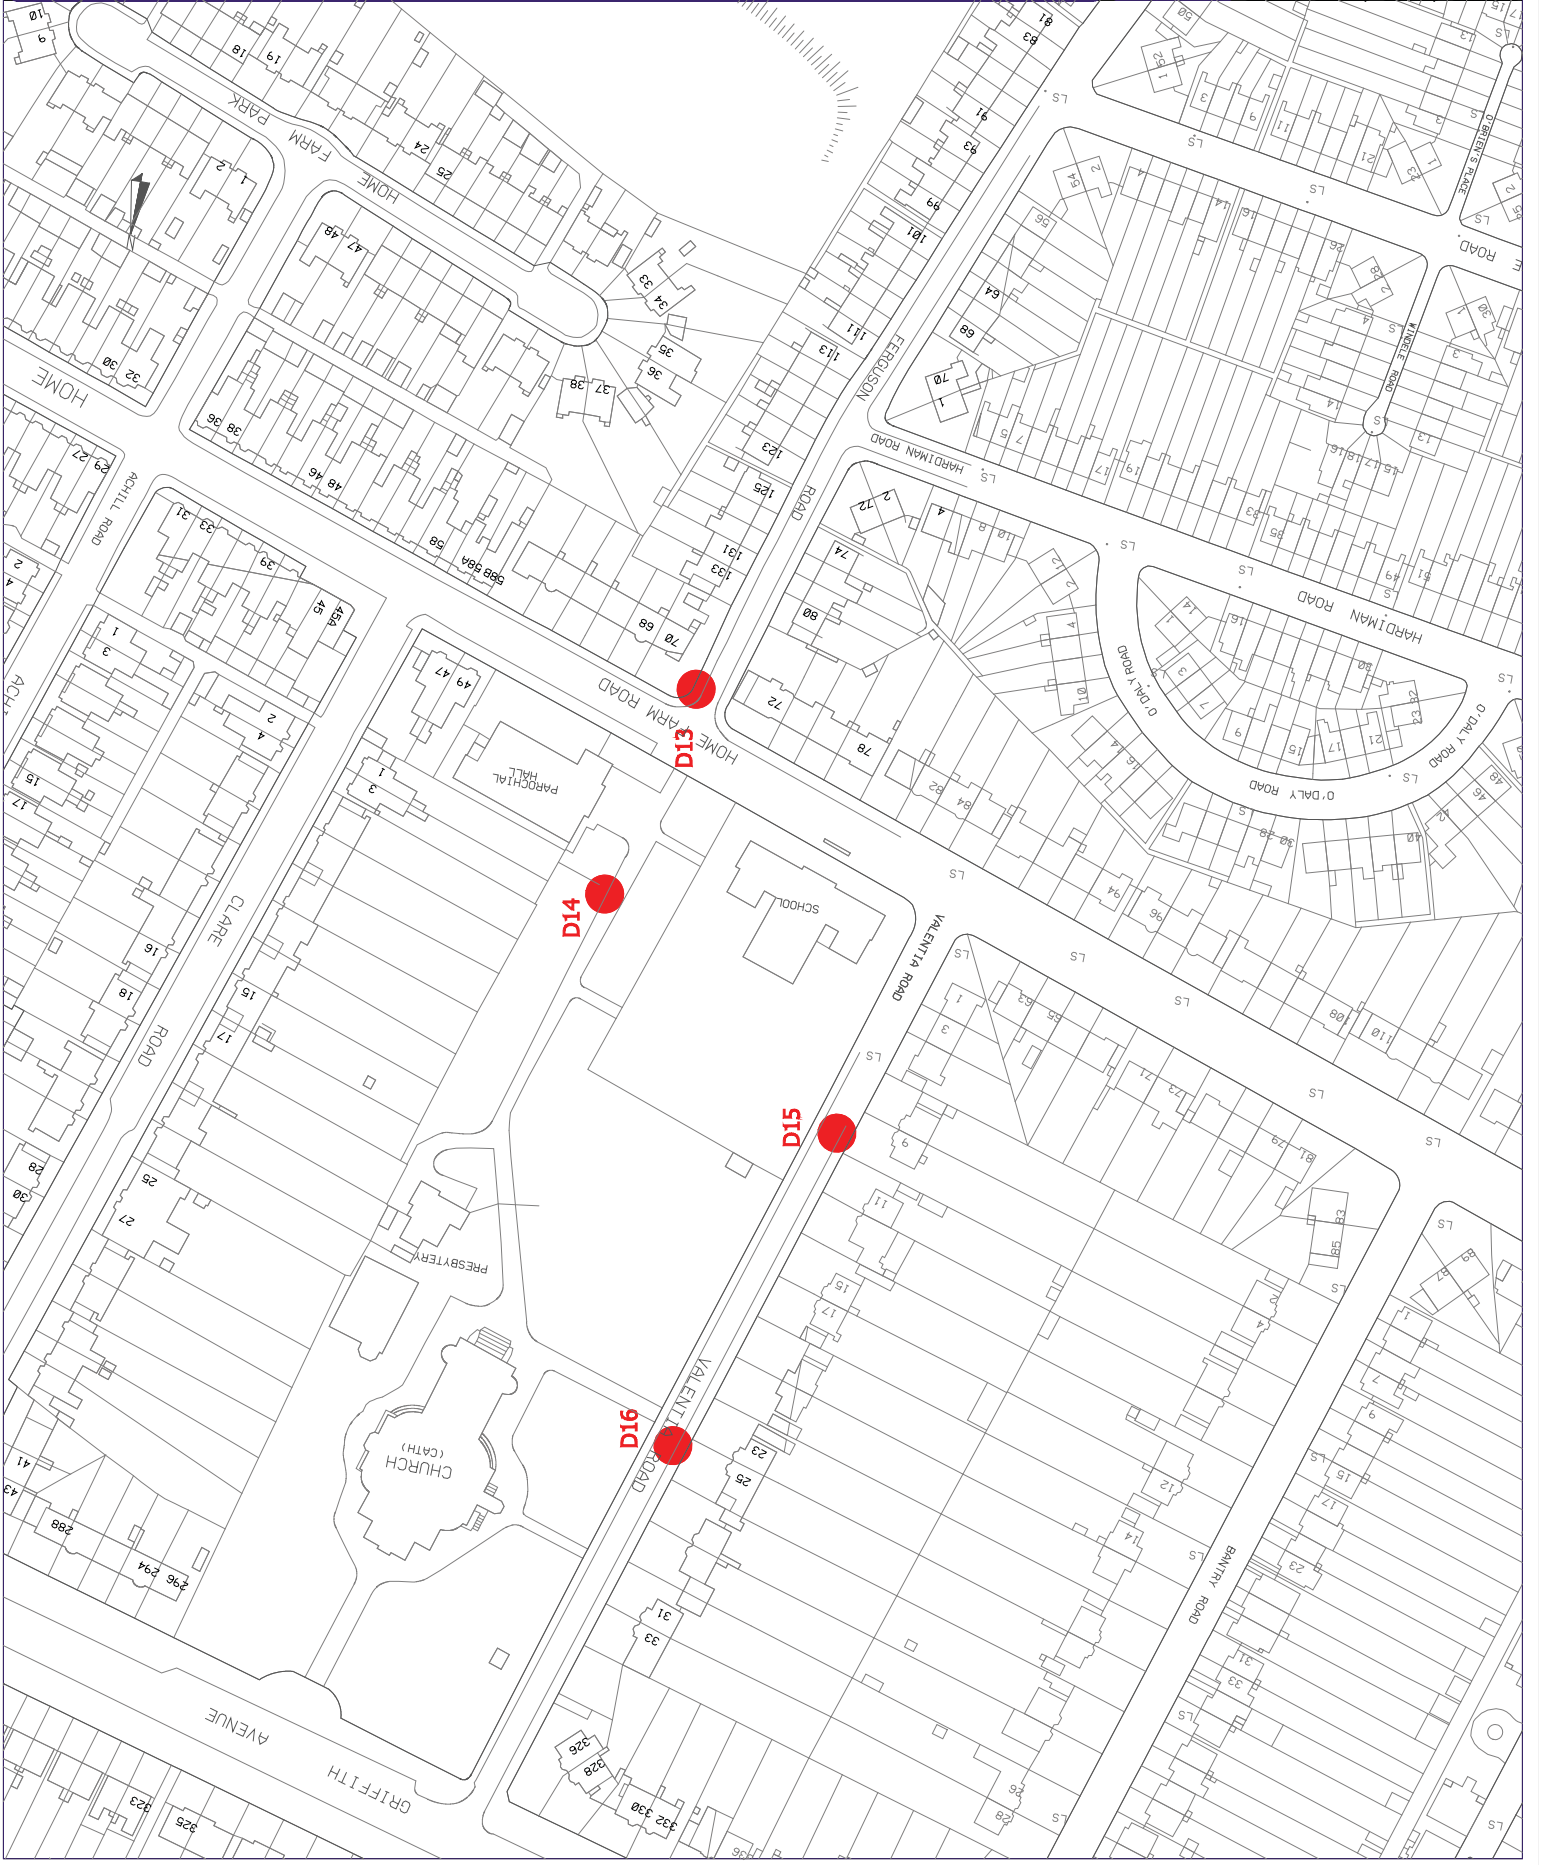
Dwg No.: TMS-HAQ025
Scale: 1:1000 AT A2
Date: 27TH JAN 2010

Title: SAMPLING POINT LOCATION MAP:
 DRUMCONDRA
