BASELINE DUST DEPOSITION SURVEY REPORT

Railway Procurement Agency
Parkgate Business Centre
Parkgate Street
Dublin 8

Report Ref. 16124
17th February 2010

This report presents the results of a dust deposition survey which was carried out at 48 sampling locations (D-1 to D-48) along the proposed Metro North alignment. Dust deposition rates have been measured over a four month period from 18th August – 16th December 2009.

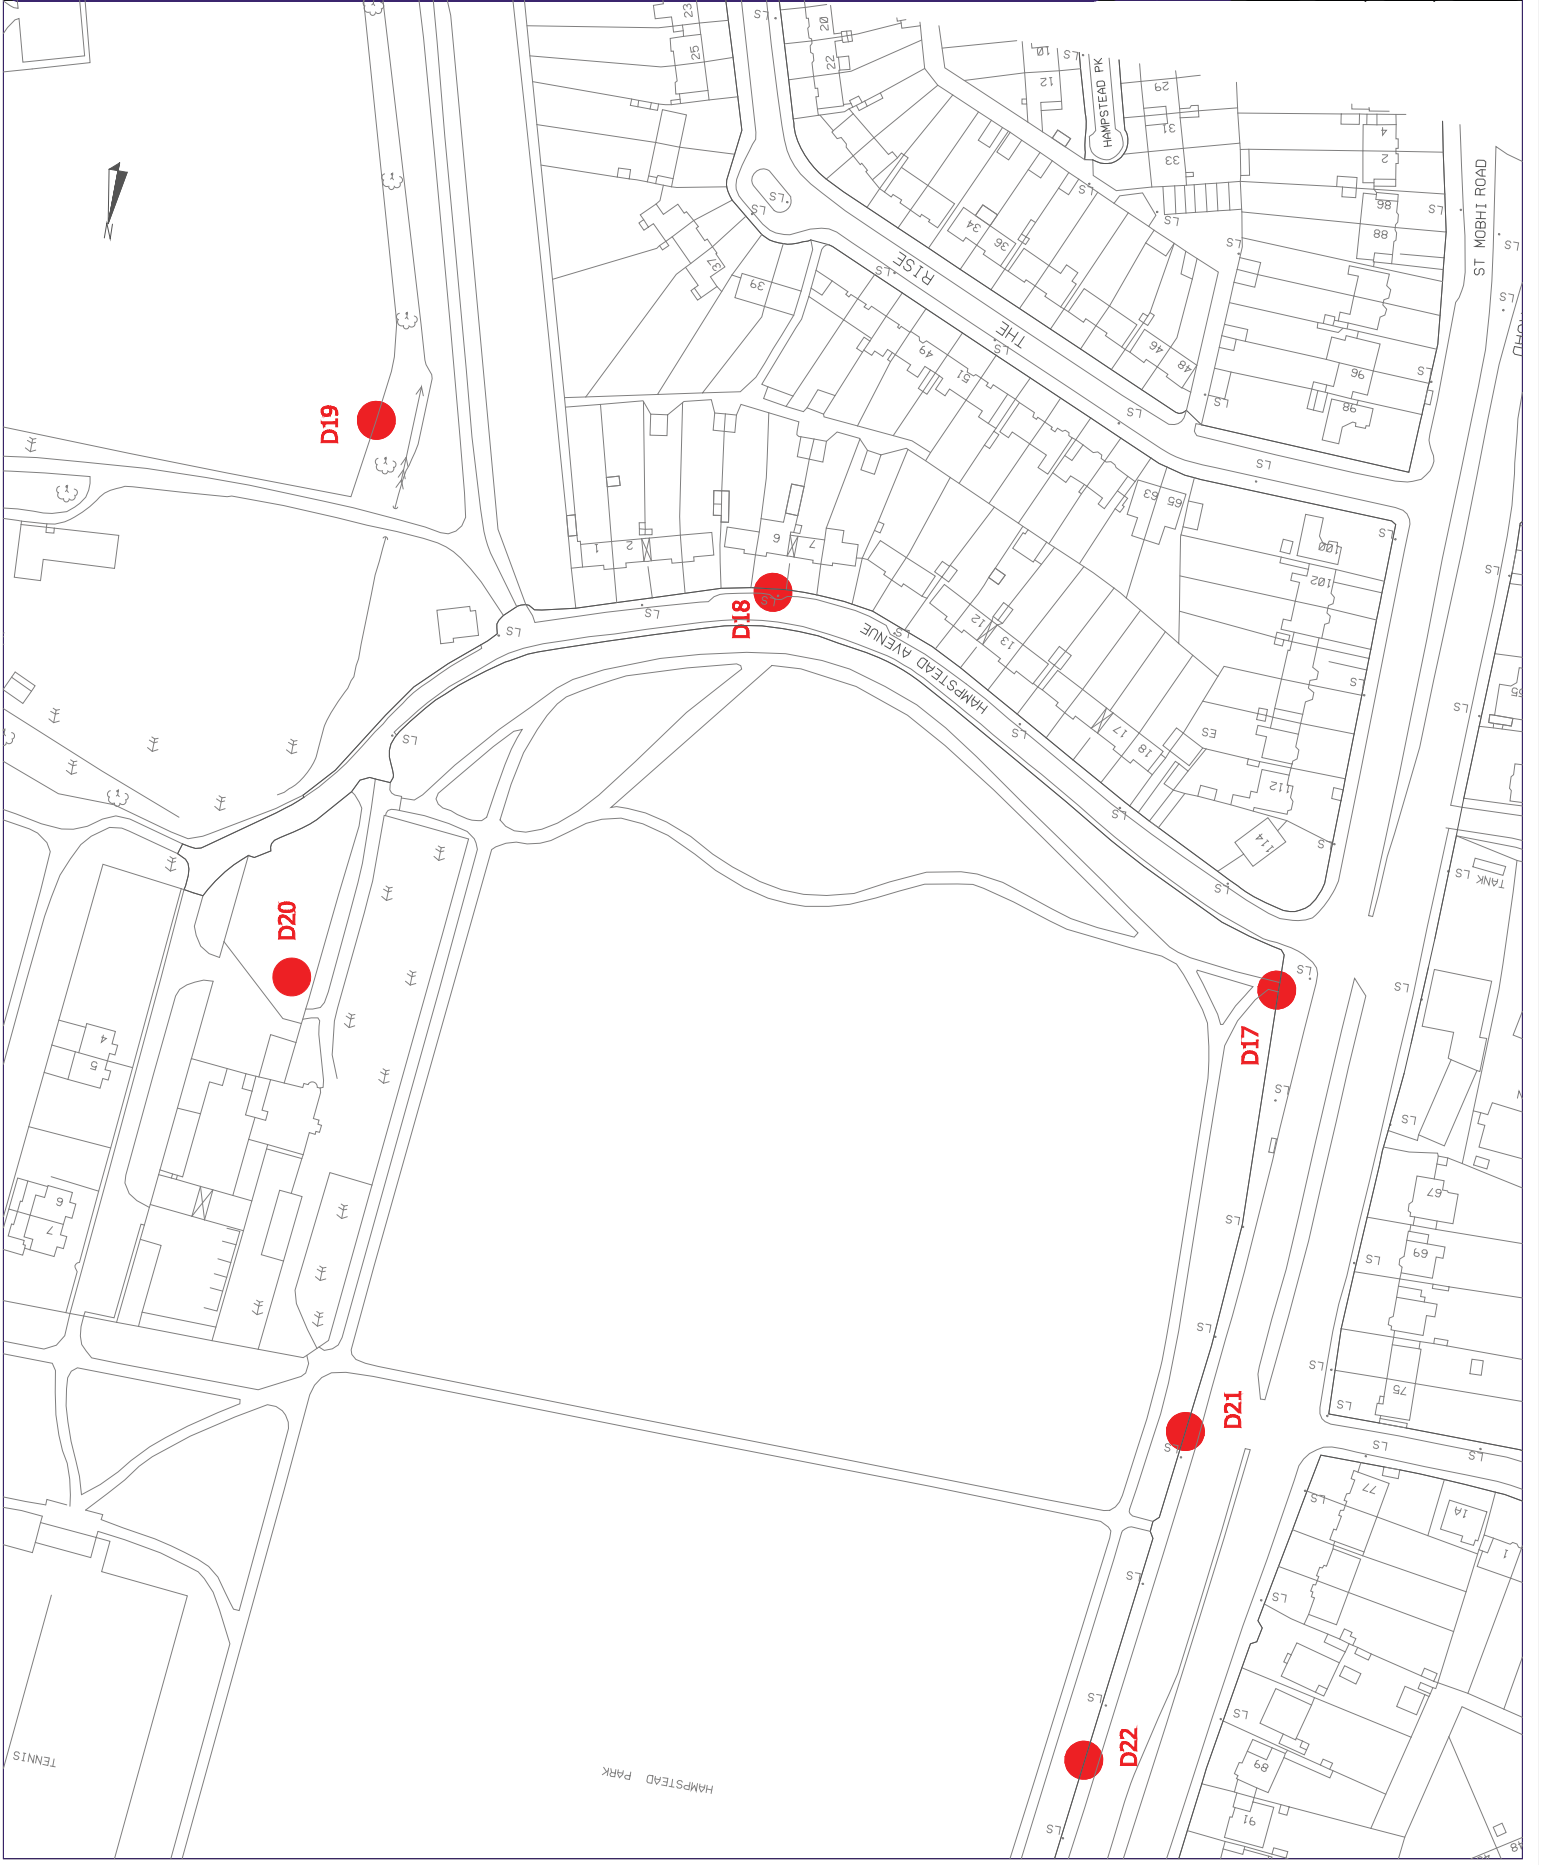
Dwg No: TMS-MN006 Project No: 15691
Scale: 1:1000 AT A2 Drawn By: TC
Date: 27TH JAN 2010 Checked By: PB

TITLE: **SAMPLING POINT LOCATION MAP:
ALBERT COLLEGE PARK**

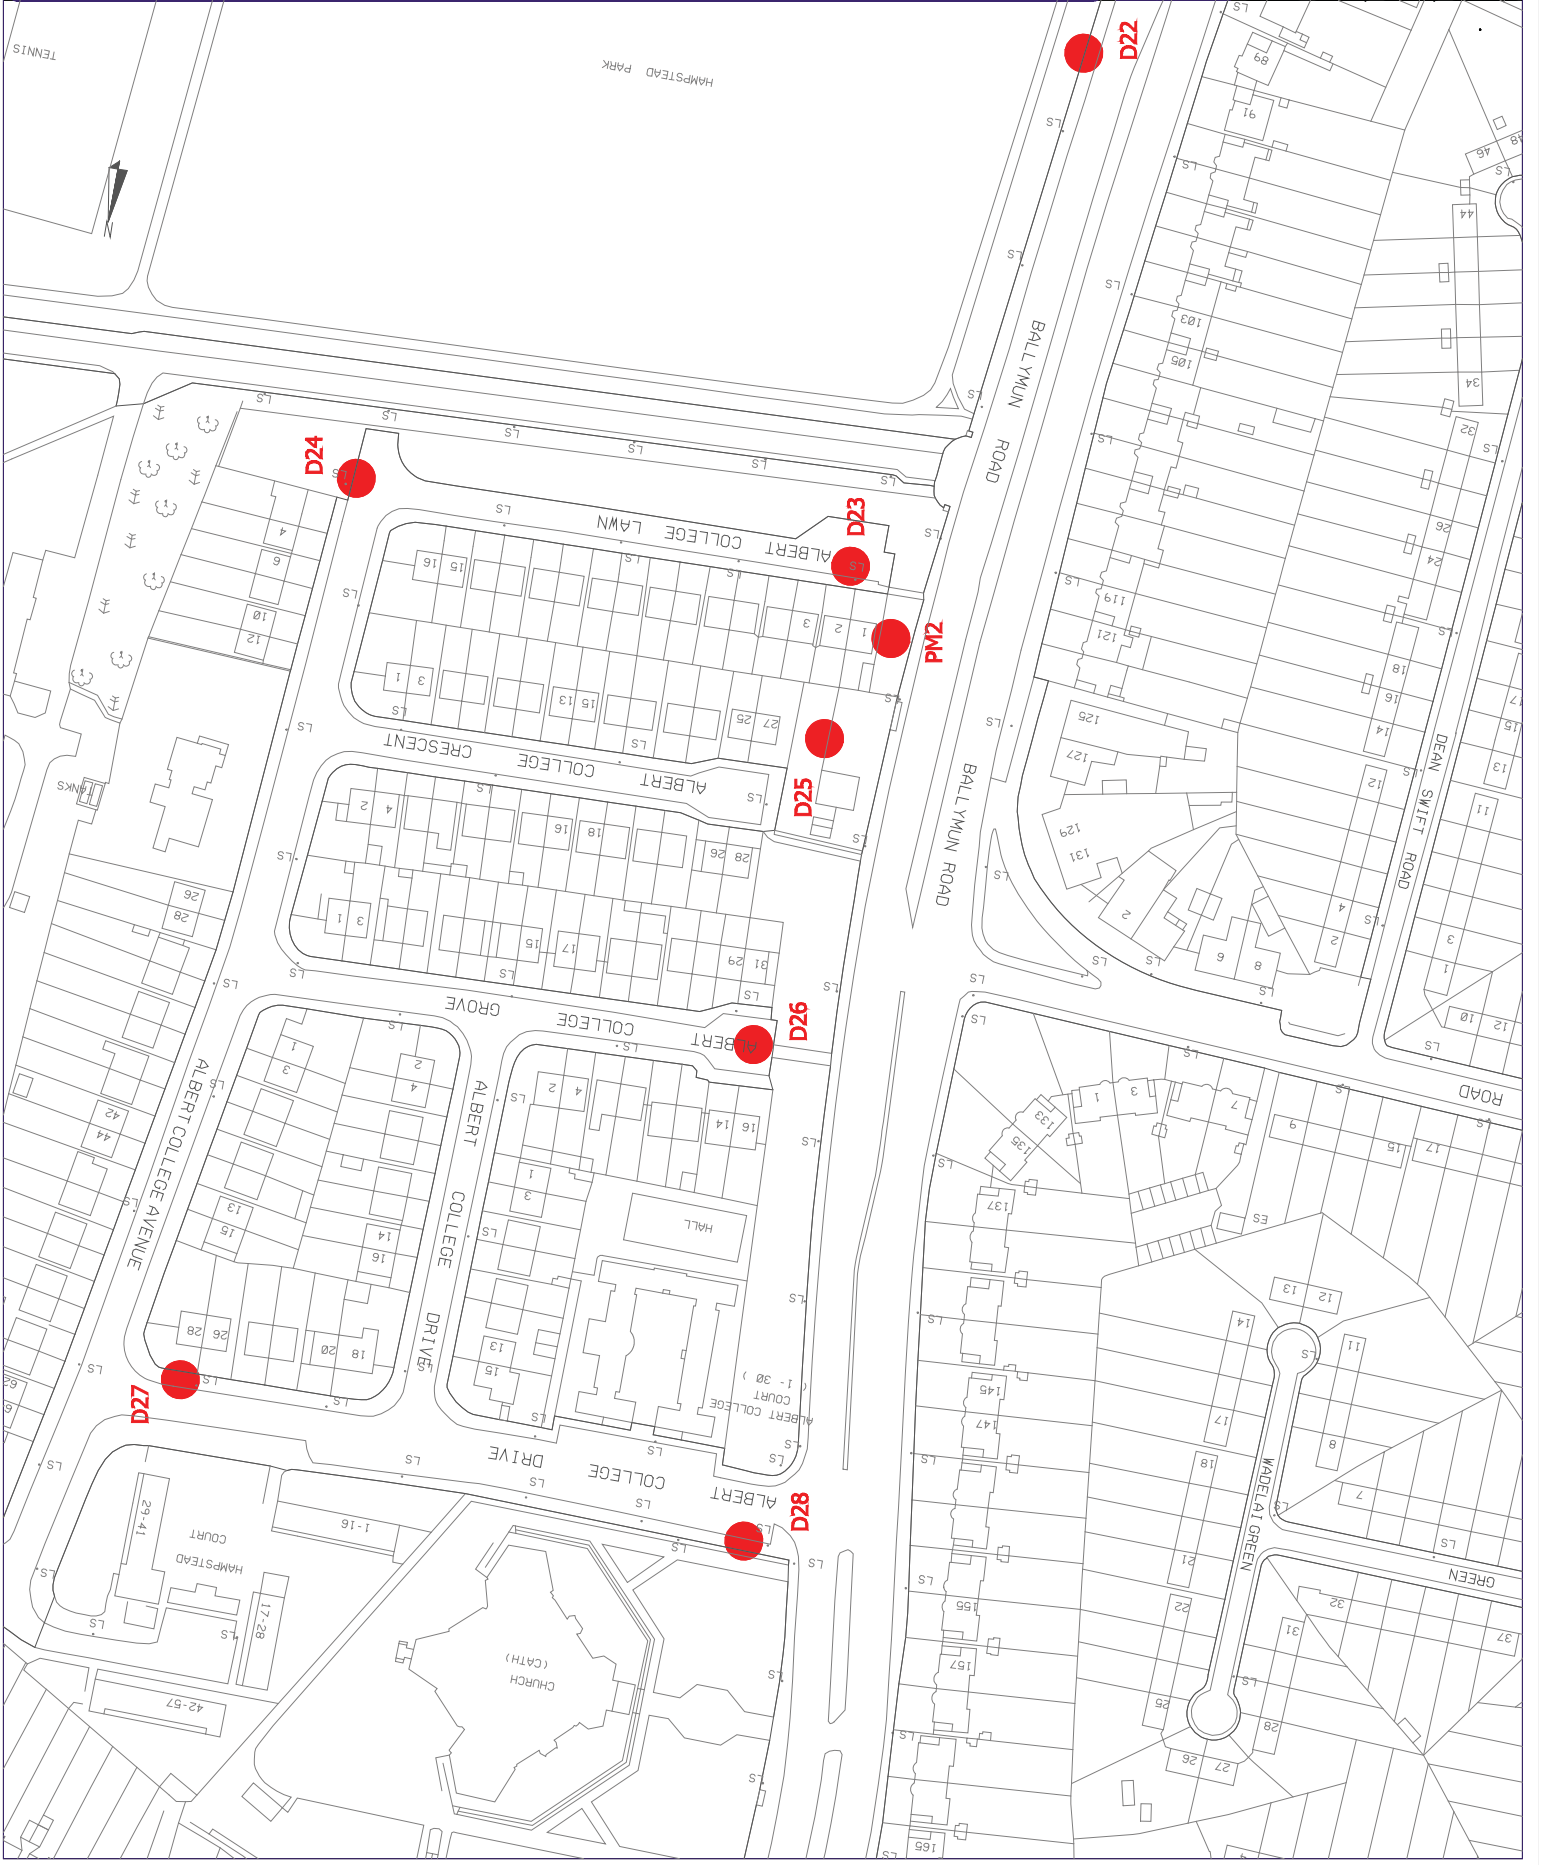
Dwg No:	TMS-PA0807	Project No.:	15691
Scale:	1:1000 AT A2	Drawn By:	TC
Date:	27TH JAN 2010	Checked By:	PB

TITLE: SAMPLING POINT LOCATION MAP:
ALBERT COLLEGE ESTATE

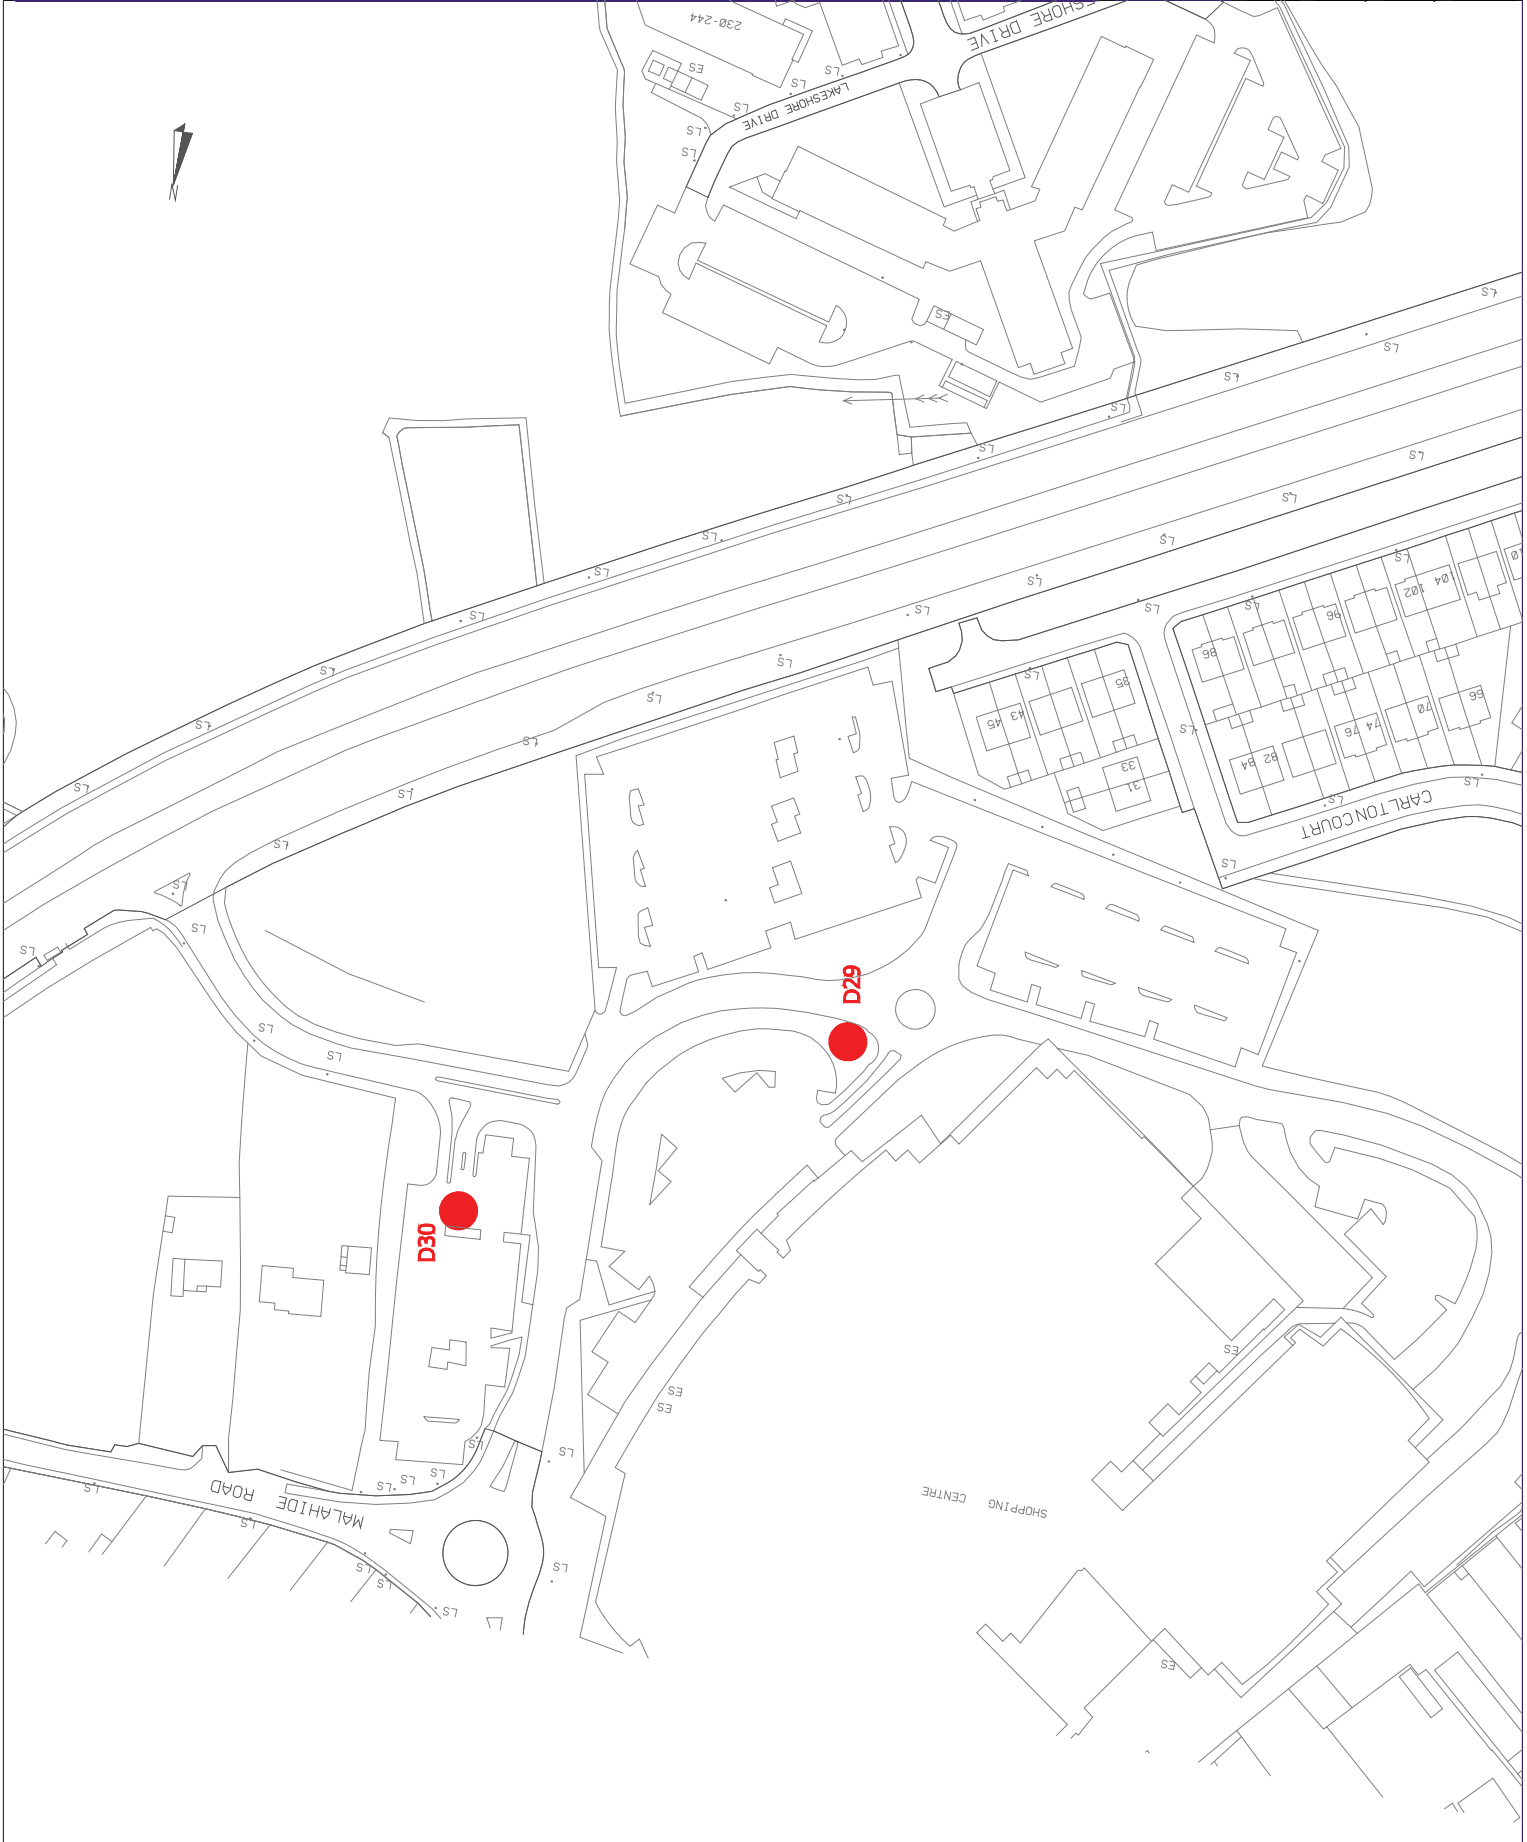
Dwg No: TMS-PA0205 Project No: 15691

SAMPLING POINT LOCATION MAP:
SWOROS PAVILION
